This hand-moulded facing brick is made from loess, which is extracted among others from the Kesselt plateau in the Maas valley (Belgium) and then enhanced with raw materials from the Volcanic Eifel.

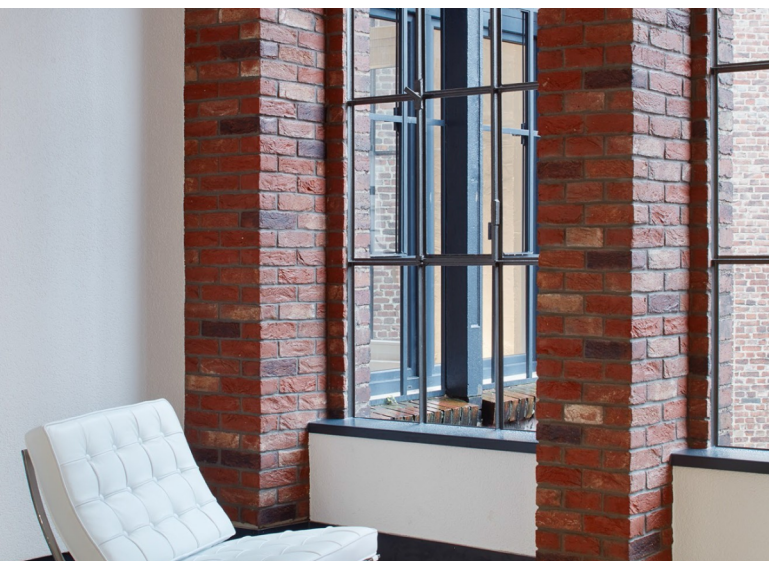
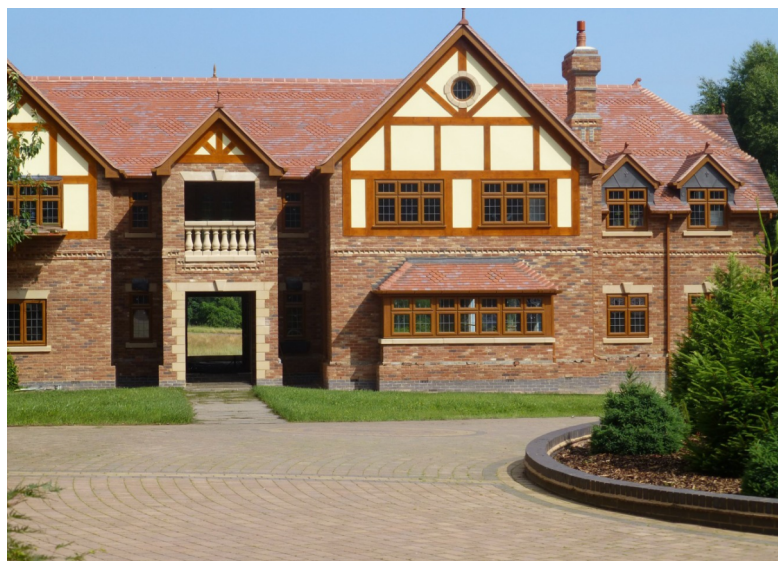
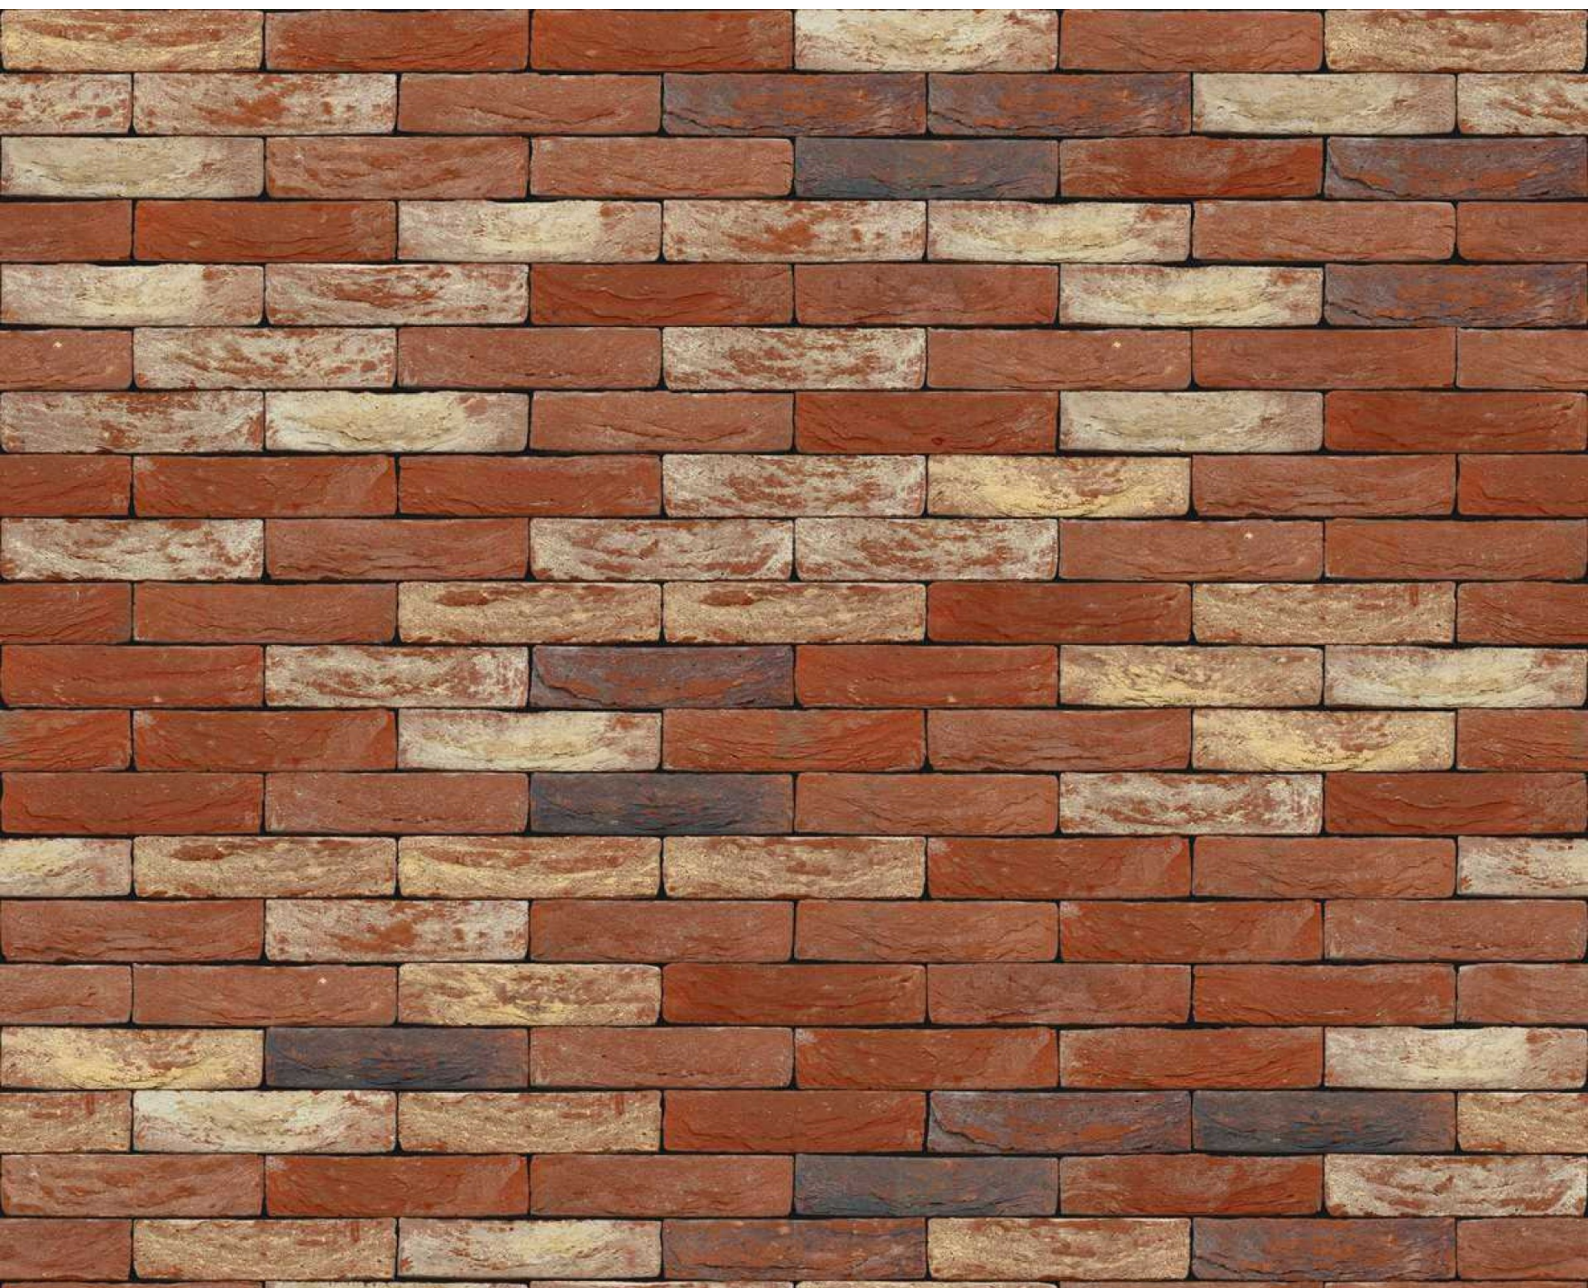
The (non-perforated) facing brick is sanded on five sides. The surface may be given a frog (a slanted oblong groove) on its bed. The structure looks rugged with fine and irregular grooves in the sandy surface. The firing process takes place in a gas-heated tunnel kiln.

The brick has a red base, with hues ranging from red to warm orange red with white and yellow shadings and blue sediments. The colours shown are a near reflection of reality.
