This hand-moulded facing brick is made from loess, which is extracted among others from the Kesselt plateau in the Maas valley (Belgium) and then enhanced with raw materials from the Volcanic Eifel.

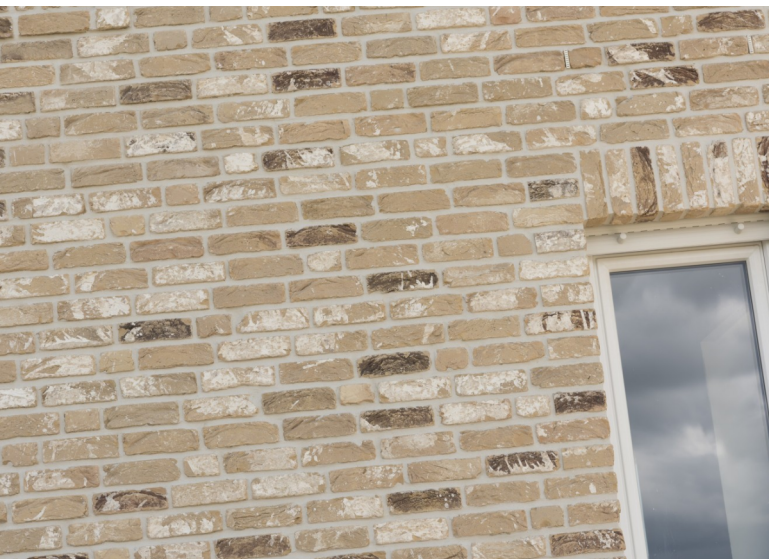
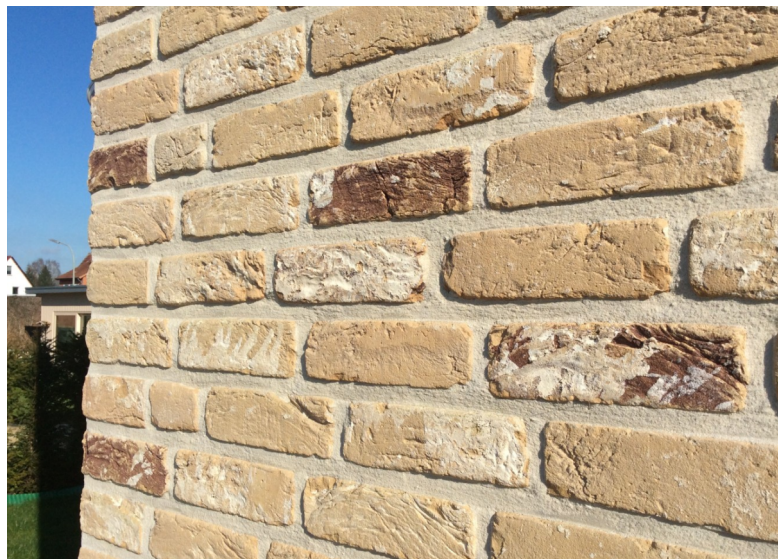
The (non-perforated) facing brick is sanded on five sides. The surface may be given a frog (a slanted oblong groove) on its bed. The firing process takes place in a gas-heated tunnel kiln. The bricks have a rough structure, irregular shape, and a strong resemblance to recovered bricks. The brick's retro appearance is achieved by using a tumbling process.

The brick has a yellow base. The mainly beige-yellow hue has an overall ecru effect with scattered pink-brown shadings and white calcareous sediments. The colours shown are a near reflection of reality.
