This hand-moulded facing brick is made from loess, which is extracted among others from the Kesselt plateau in the Maas valley (Belgium) and then enhanced with raw materials from the Volcanic Eifel.

The colour of the Roca is grey alternated with dark colour deposits. The colours shown are a near reflection of reality.

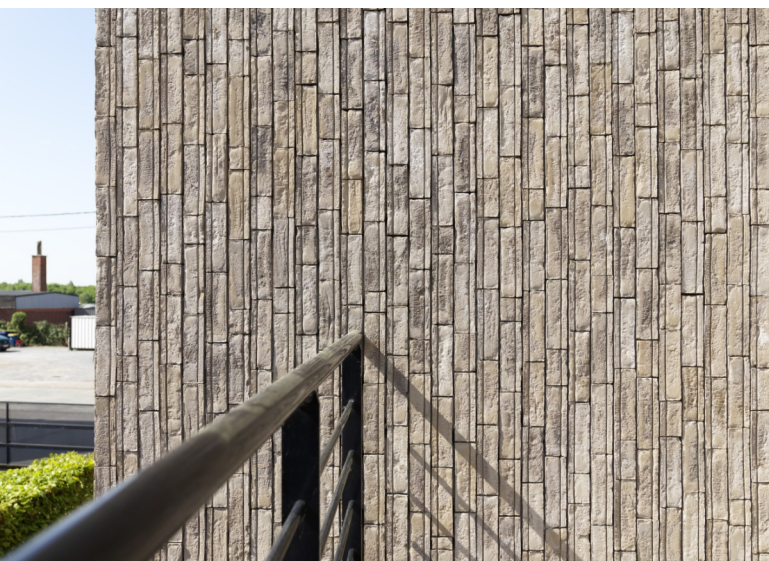
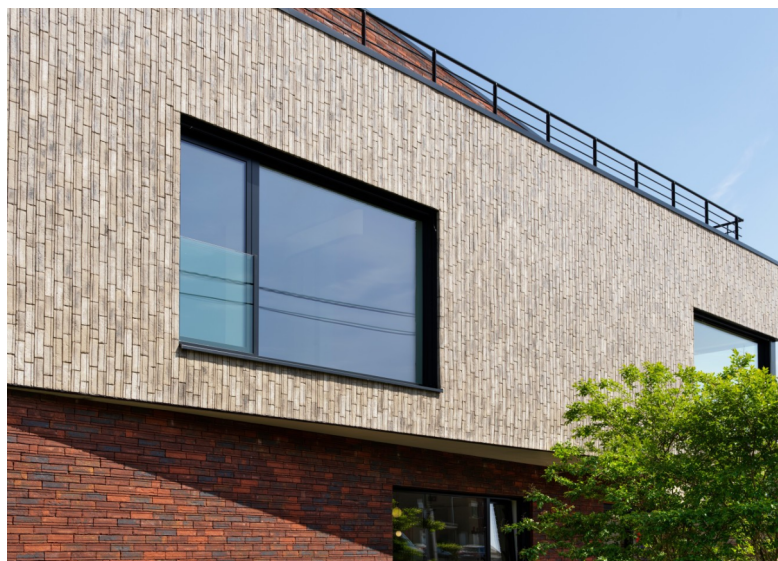
The (non-perforated) facing brick is sanded on five sides. The structure looks rugged with fine and irregular grooves in the sandy surface. The firing process takes place in a gas-heated tunnel kiln. DUBIO exists in 2 variants: DUBIO 1 = DUBIO with 1 shadow joint on the stretcher face (asymmetrical shadow joint) and DUBIO 2 = DUBIO with 2 shadow joints on the stretcher face (double symmetric shadow joint). The line pattern continues on at least one header face of the brick. The thickness of the shadow joint is  $\pm 4$  mm.
