This hand-moulded facing brick is made from loess, which is extracted among others from the Kesselt plateau in the Maas valley (Belgium) and then enhanced with raw materials from the Volcanic Eifel.

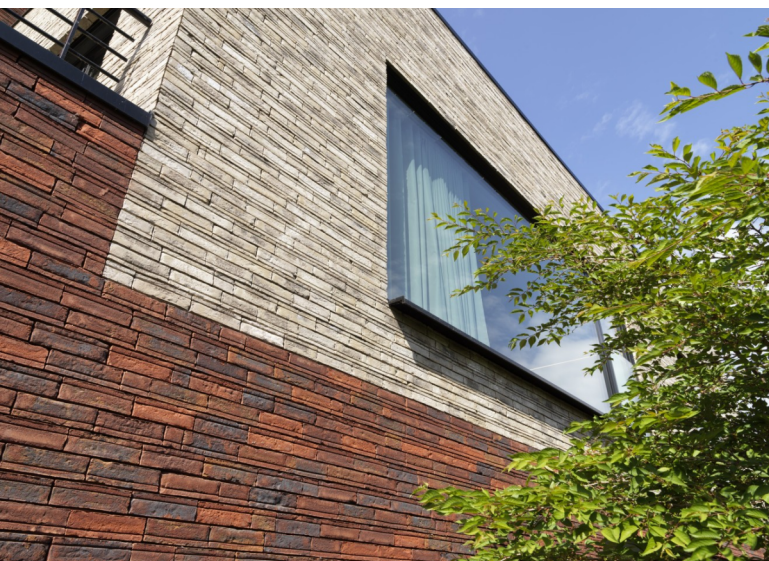
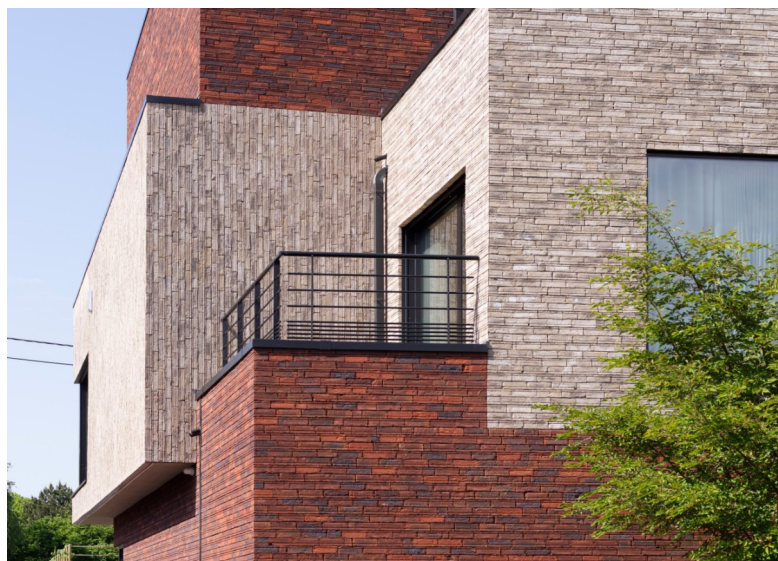
The (non-perforated) facing brick is sanded on five sides. The structure looks rugged with fine and irregular grooves in the sandy surface. The firing process takes place in a gas-heated tunnel kiln. DUBIO exists in 2 variants: DUBIO 1 = DUBIO with 1 shadow joint on the stretcher face (asymmetrical shadow joint) and DUBIO 2 = DUBIO with 2 shadow joints on the stretcher face (double symmetric shadow joint). The line pattern continues on at least one header face of the brick. The thickness of the shadow joint is  $\pm 4$ mm.

The brick has a red base, with hues that vary from orange red to burgundy with blue, yellow-green and dark-purple shades. The colours shown are a near reflection of reality.
