This hand-moulded facing brick is made from loess, which is extracted among others from the Kesselt plateau in the Maas valley (Belgium) and then enhanced with raw materials from the Volcanic Eifel.

#### ASPECT AND STRUCTURE

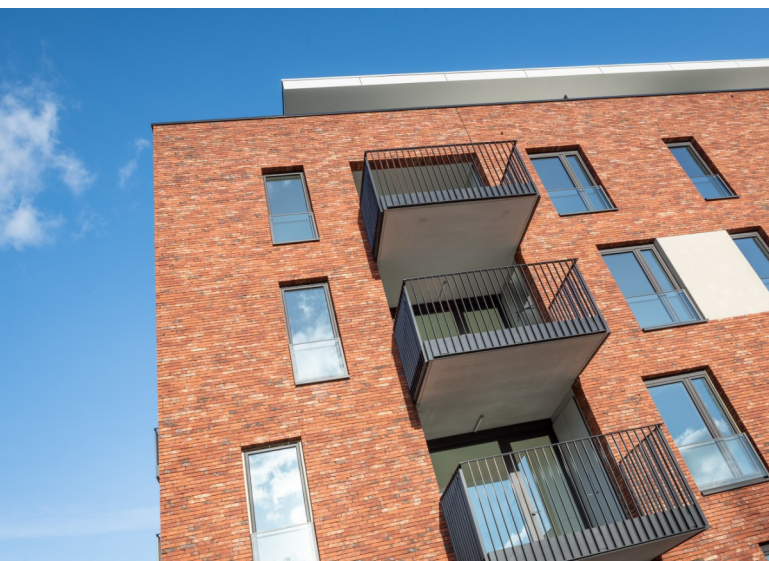
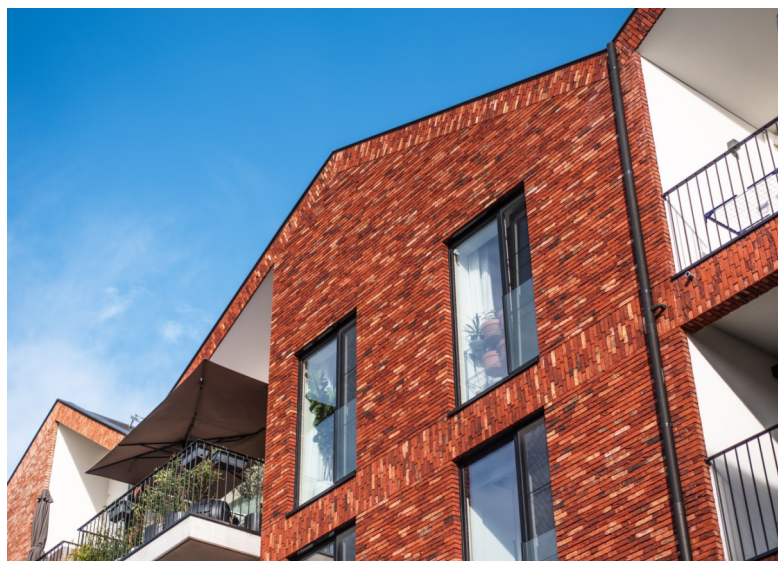
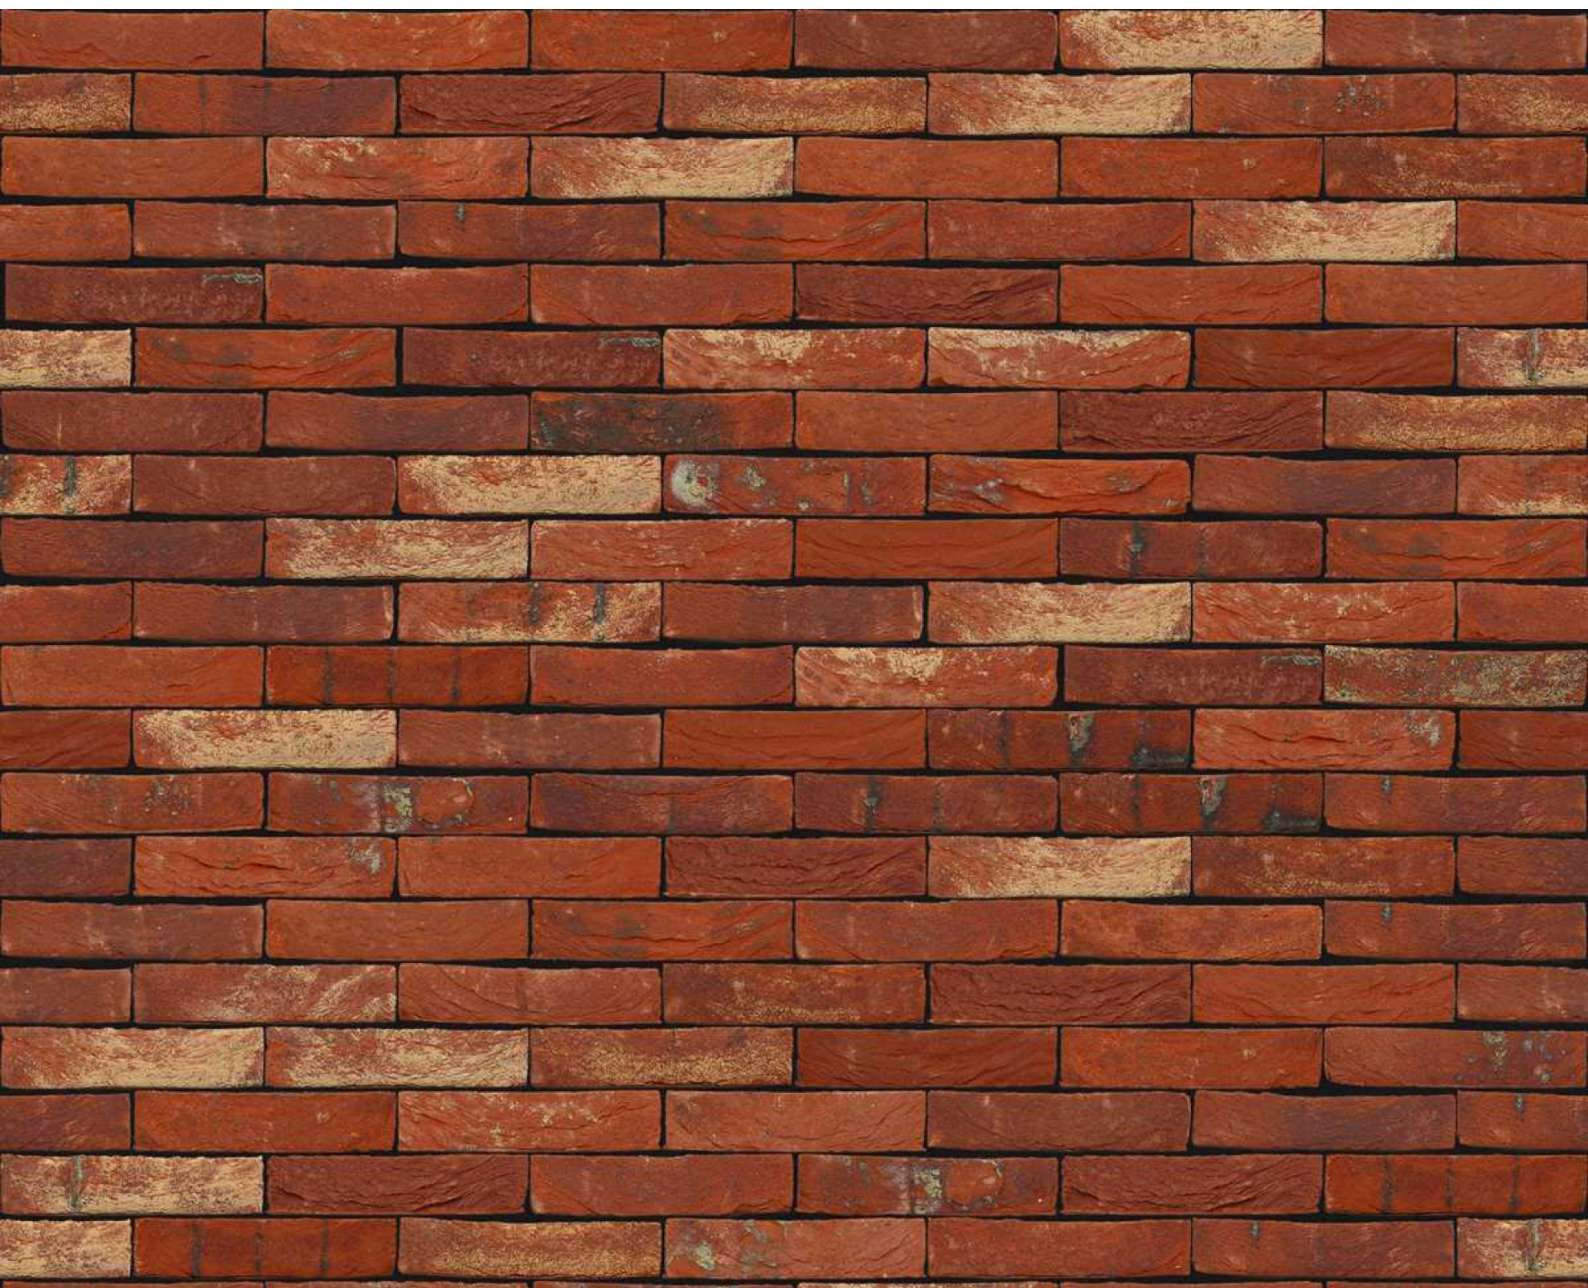
The (non-perforated) facing brick is sanded on five sides. The surface may be given a frog (a slanted oblong groove) on its bed. The structure looks rugged with fine and irregular grooves in the sandy surface. The firing process takes place in a gas-heated tunnel kiln.

The brick has a red base, with colours ranging from orange red to dark red. The darker shade on the facing brick is obtained by means of coalsintering. The colours shown are a near reflection of reality.
