This hand-moulded facing brick is made from loess, which is extracted among others from the Kesselt plateau in the Maas valley (Belgium) and then enhanced with raw materials from the Volcanic Eifel.

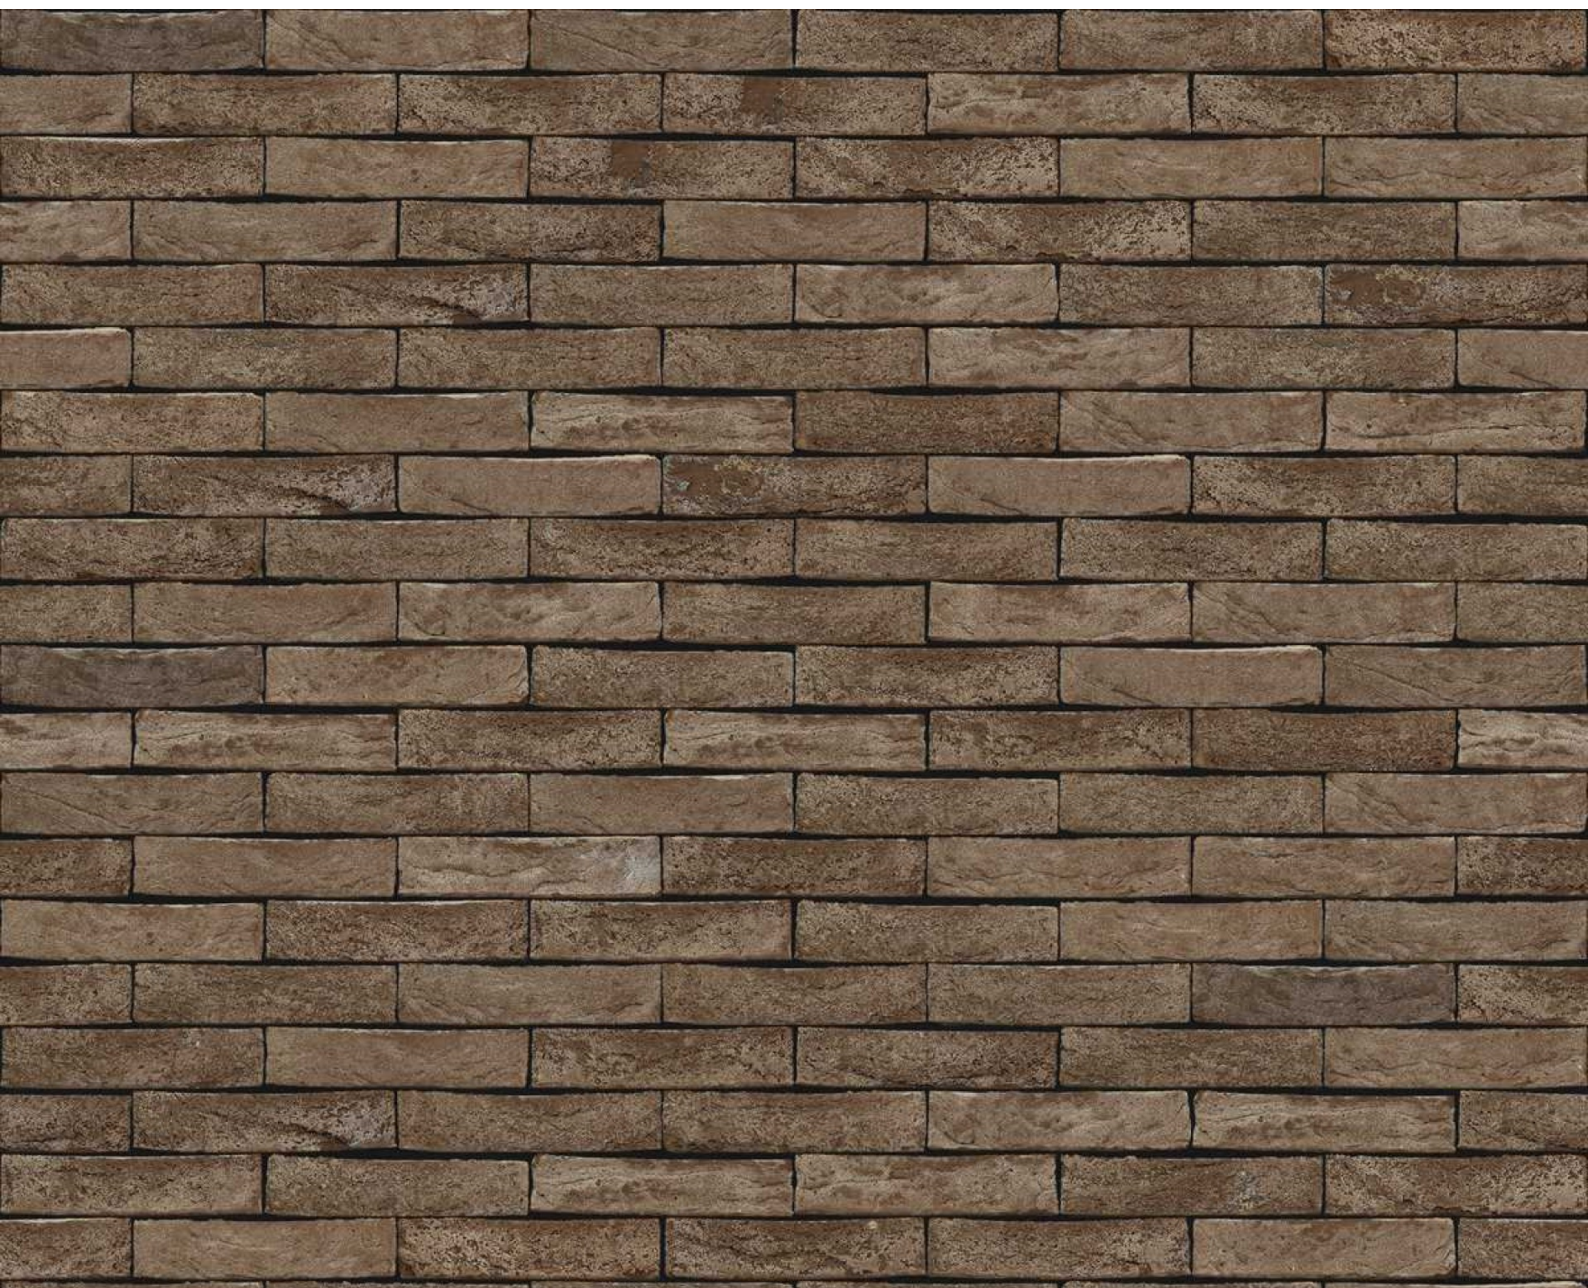
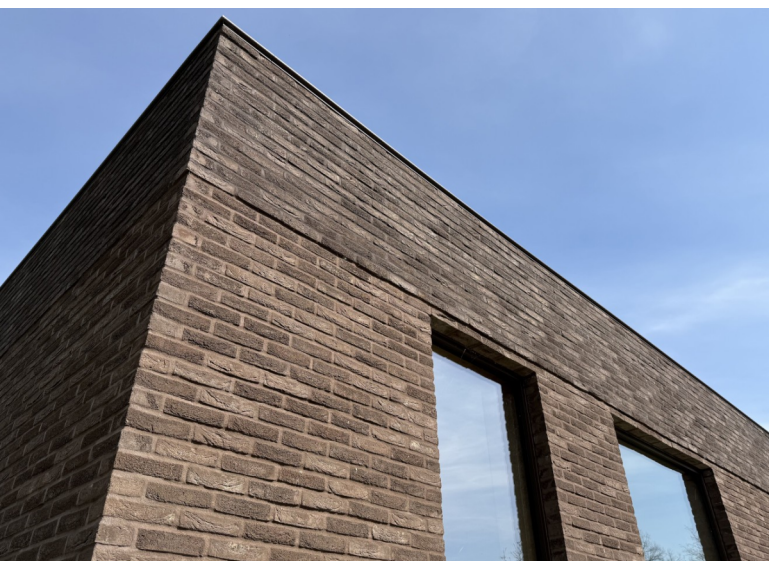
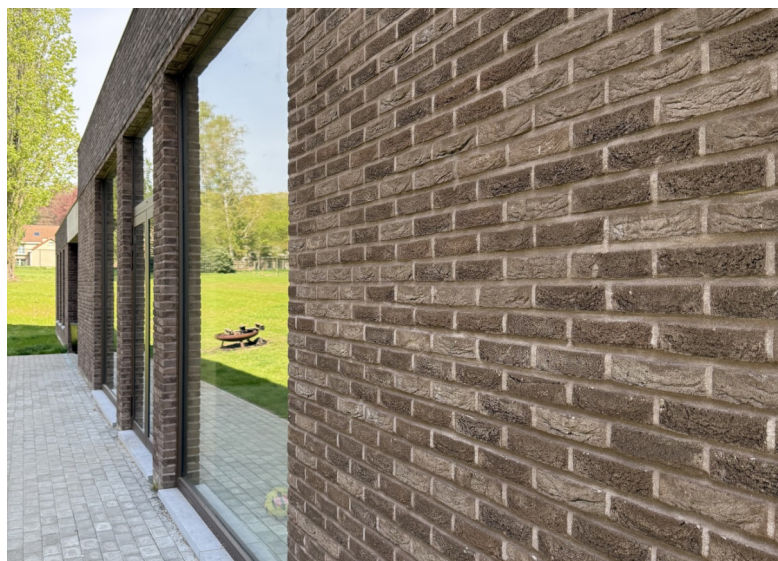
The (non-perforated) facing brick is sanded on five sides. The surface may be given a frog (a slanted oblong groove) on its bed. The structure looks rugged with fine and irregular grooves in the sandy surface. The firing process takes place in a gas-heated tunnel kiln.

The brick has a grey-brown base. The colour ranges from mainly grey to dark grey. Through sintering of the brick, the different nuances of colour are obtained. The colours shown are a near reflection of reality.
