This hand-moulded facing brick is made from loess, which is extracted among others from the Kesselt plateau in the Maas valley (Belgium) and then enhanced with raw materials from the Volcanic Eifel.

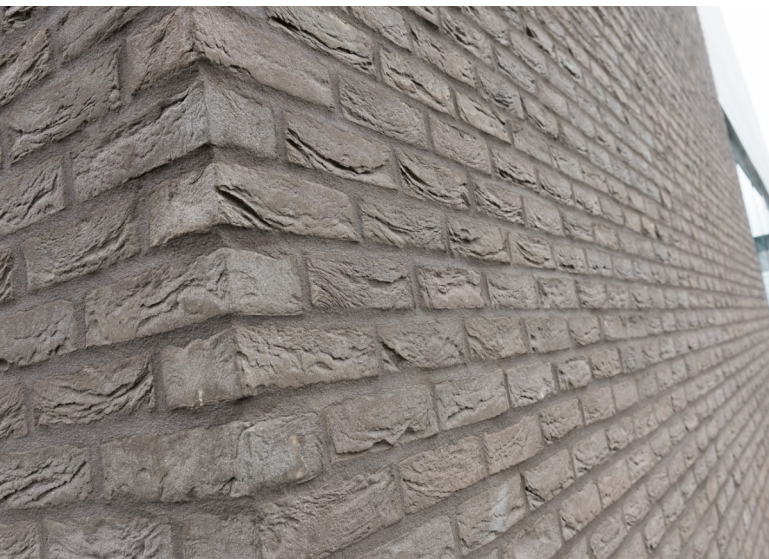
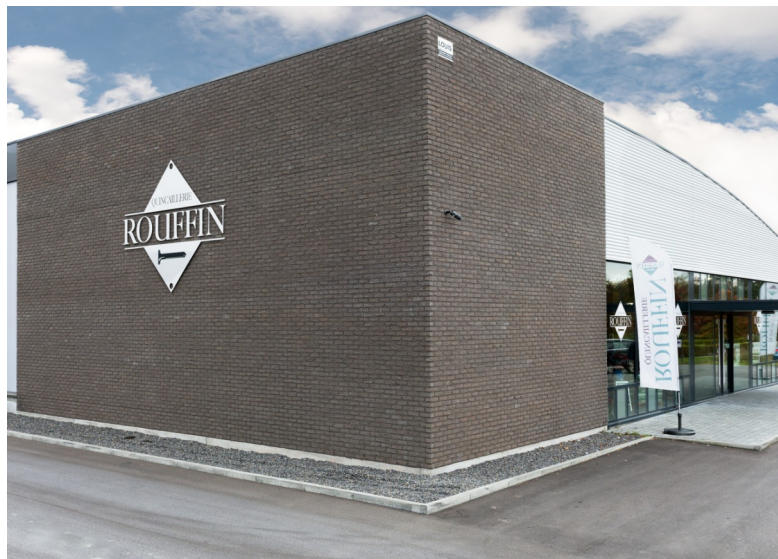
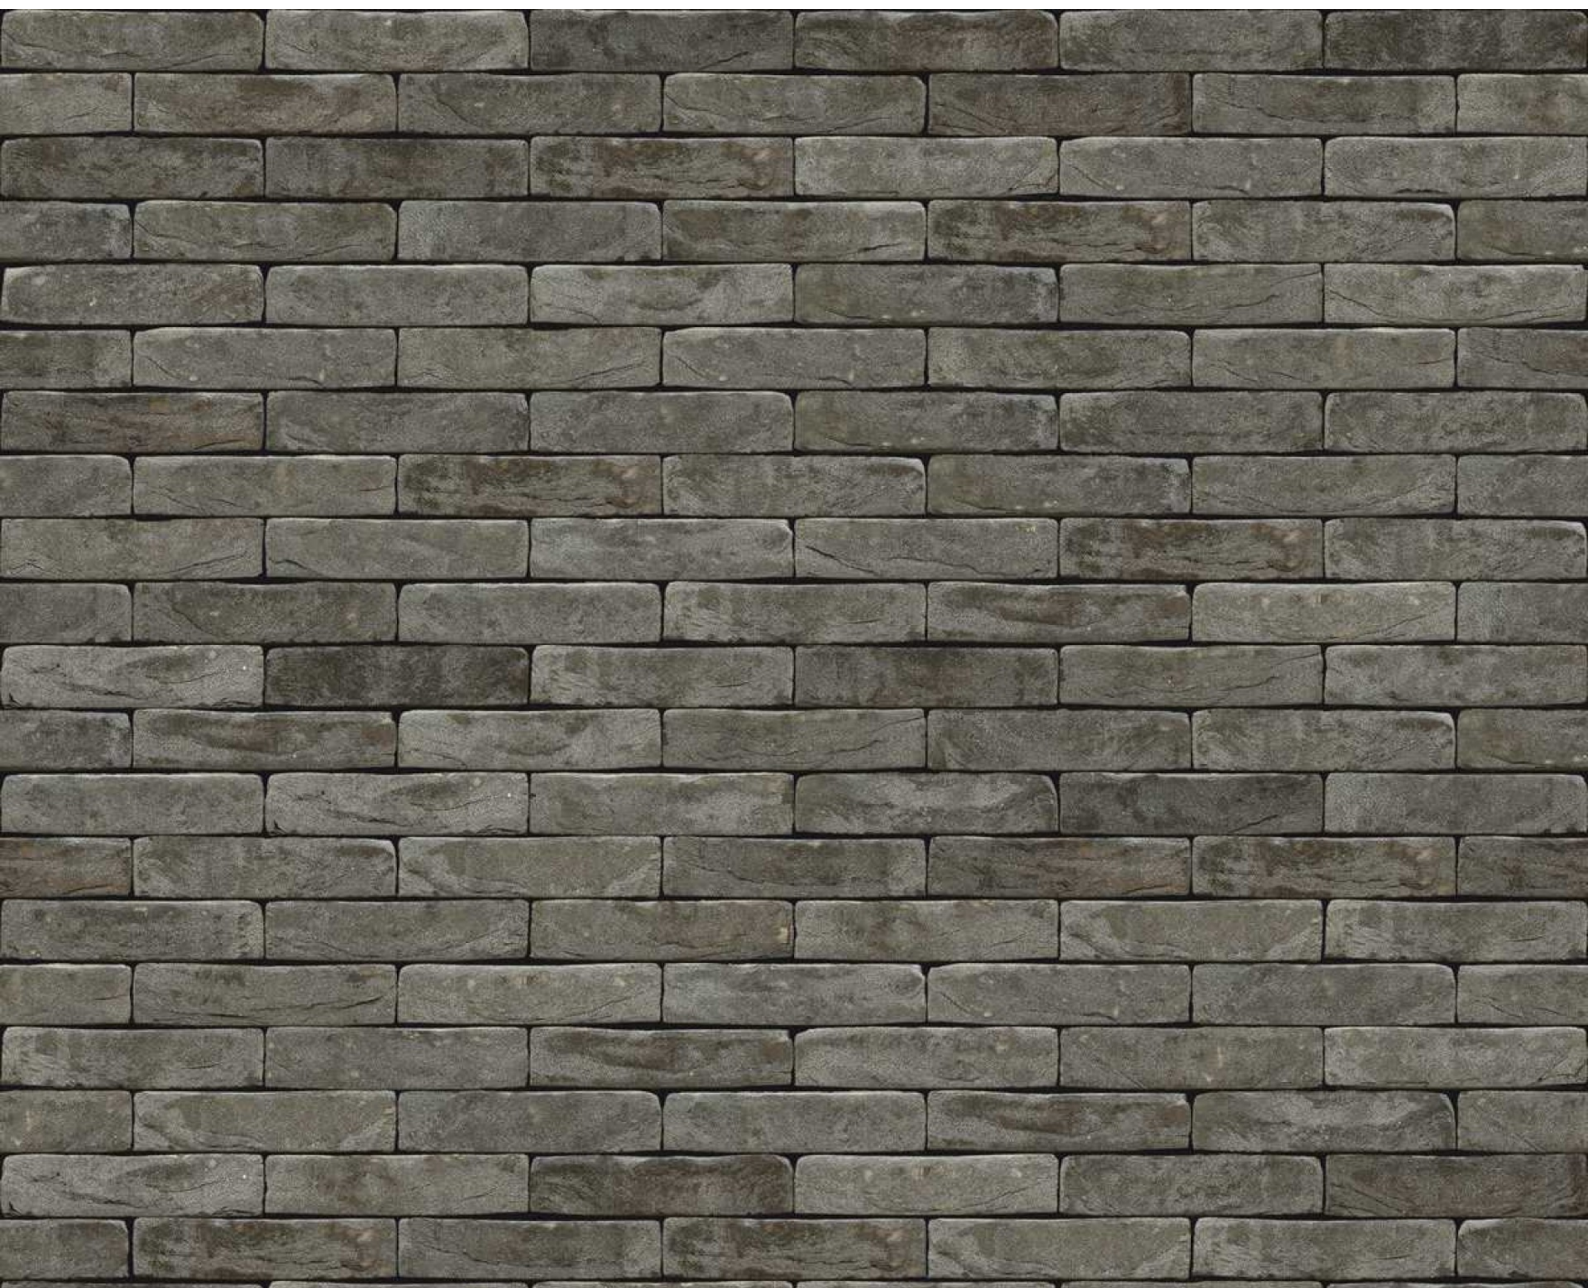
The (non-perforated) facing brick is sanded on five sides. The surface may be given a frog (a slanted oblong groove) on its bed. The structure looks rugged with fine and irregular grooves in the sandy surface. The firing process takes place in a gas-heated tunnel kiln.

The brick has a grey-anthracite base. The colour is obtained by a second firing of the bricks in a low oxygen environment. This process can generate light shadings. The colours shown are a near reflection of reality.
