This hand-moulded facing brick is made from loess, which is extracted among others from the Kesselt plateau in the Maas valley (Belgium) and then enhanced with raw materials from the Volcanic Eifel.

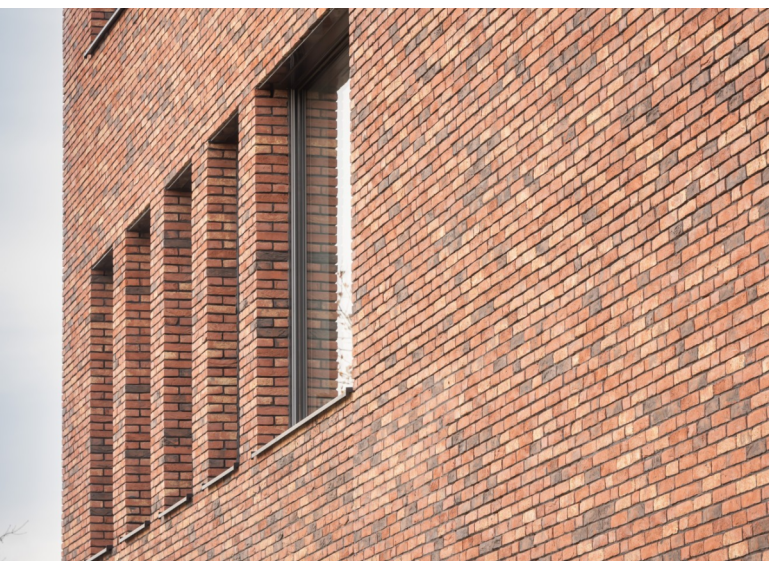
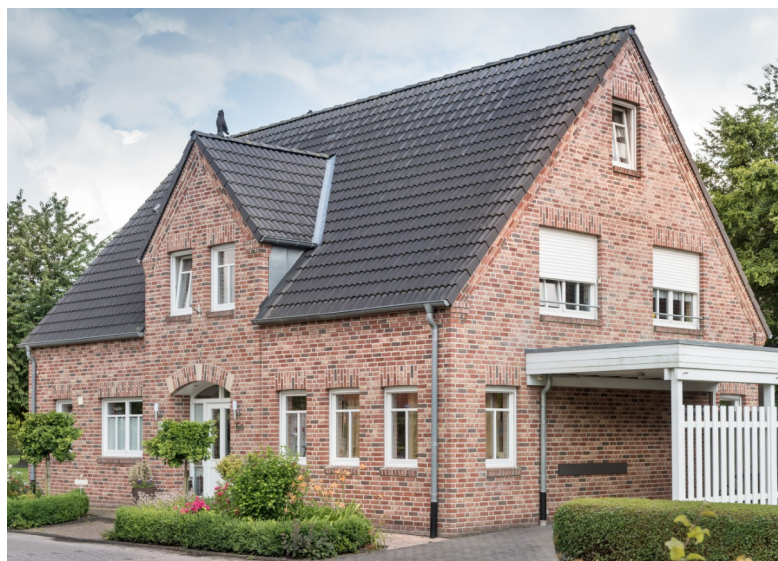
The brick has a red base, with hues ranging from brownred with yellowish shadings to grey-black. The different structures are the result of sawdust on the one hand and white, fine-grained sand on the other. The colours shown are a near reflection of reality.

The (non-perforated) facing brick is sanded on five sides. The surface may be given a frog (a slanted oblong groove) on its bed. The structure looks rugged with fine and irregular grooves in the sandy surface. The firing process takes place in a gas-heated tunnel kiln.
