This hand-moulded facing brick is made from loess, which is extracted among others from the Kesselt plateau in the Maas valley (Belgium) and then enhanced with raw materials from the Volcanic Eifel.

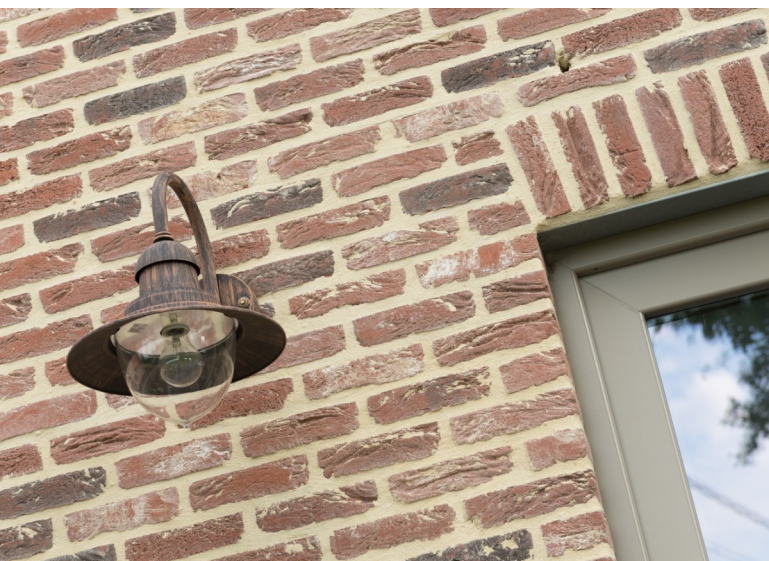
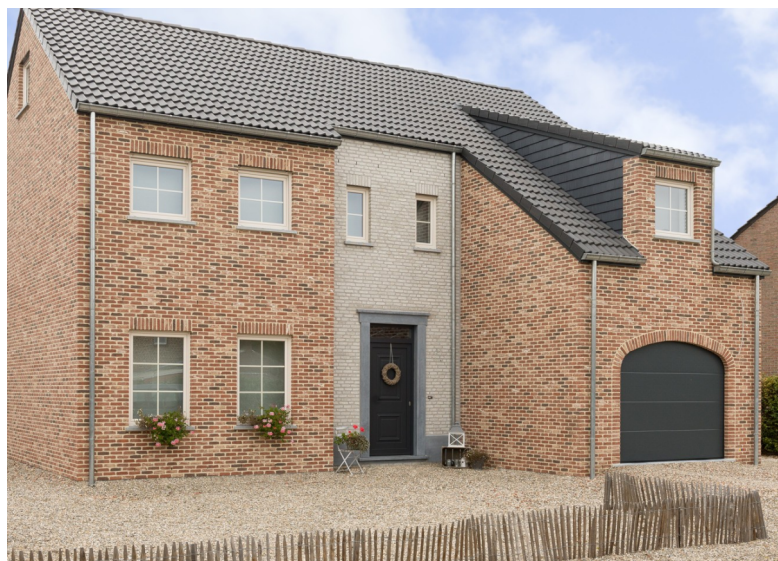
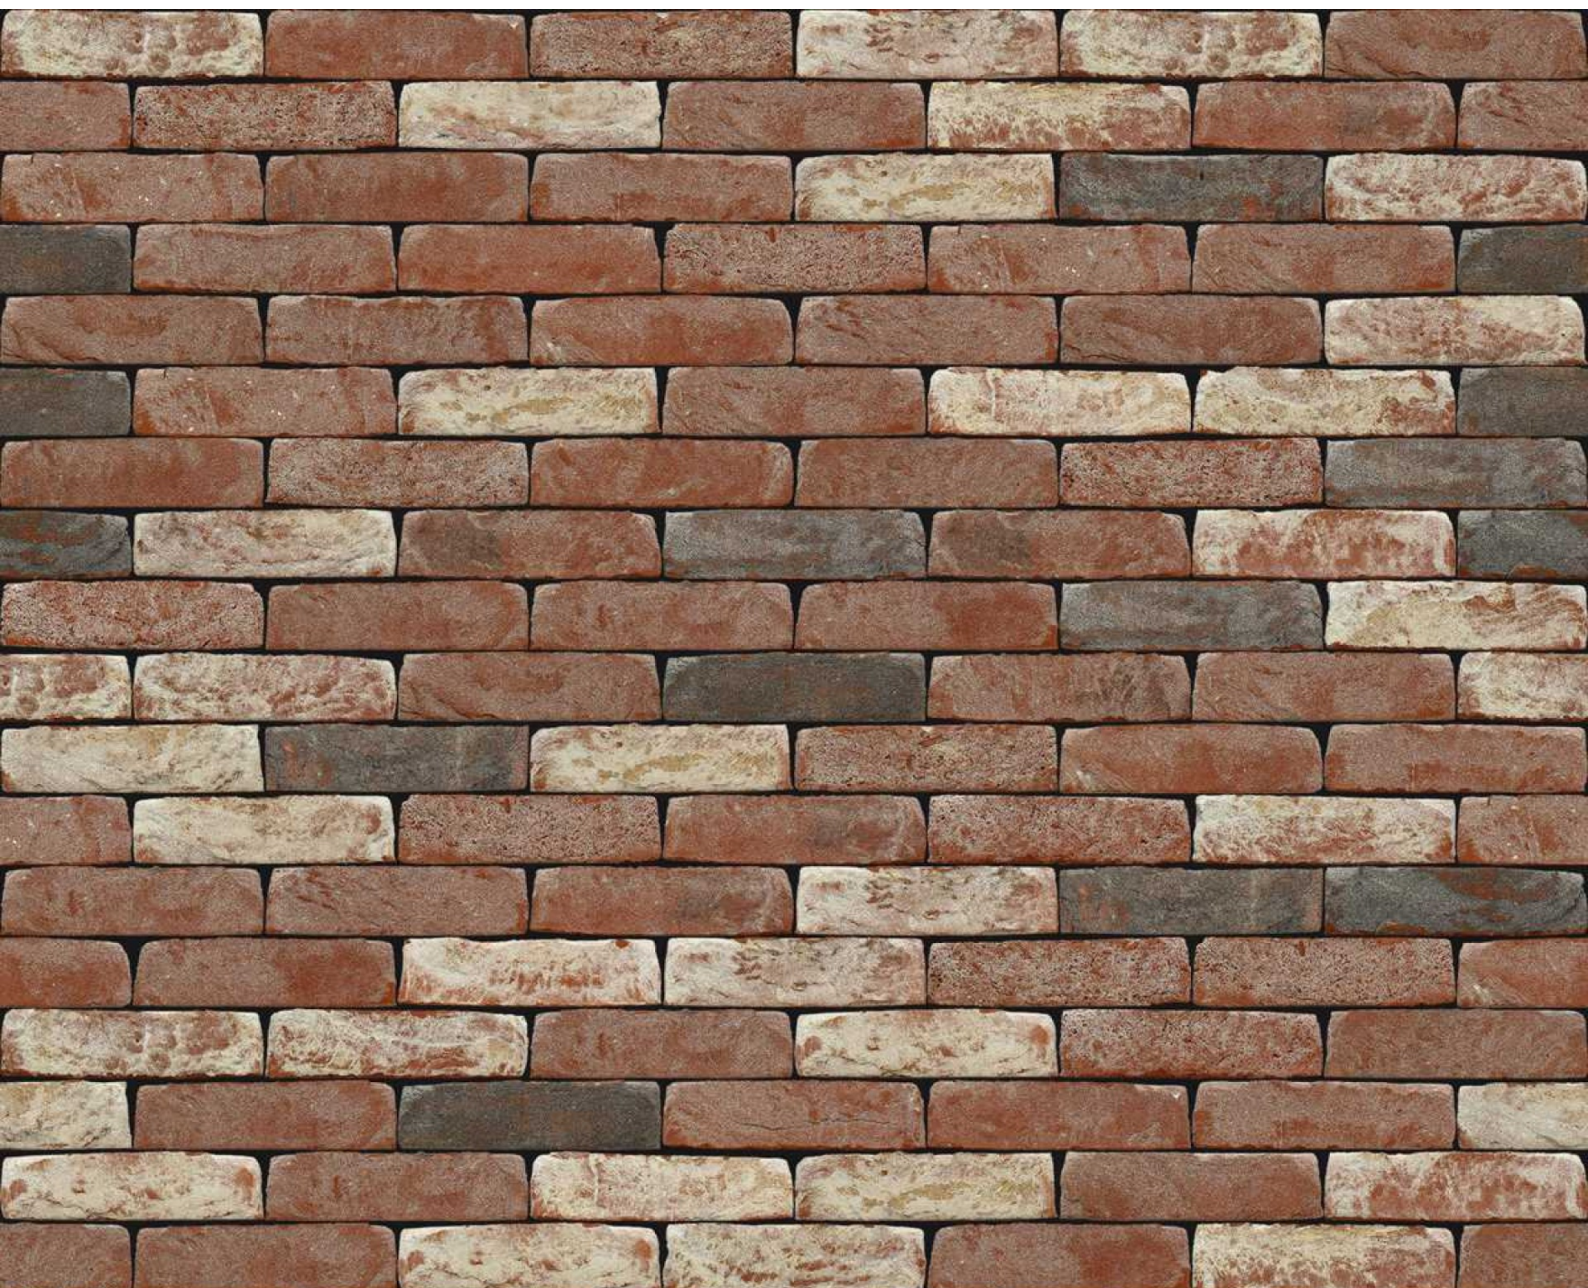
The brick has a red base. The typical old aspect is the result of the wet and unbaked bricks' treatment with various admixtures. In addition, the various types of sand are responsible for calcareous sediments slightly diminishing the red colour. The hues range from soft red to dark red with beige, white and grey shadings. The different structures are the result of sawdust on the one hand and white, fine-grained sand on the other. The colours shown are a near reflection of reality.
