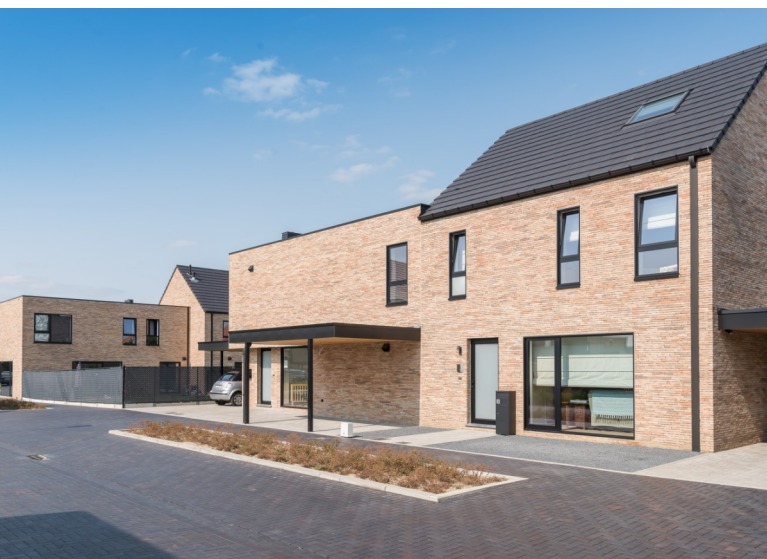
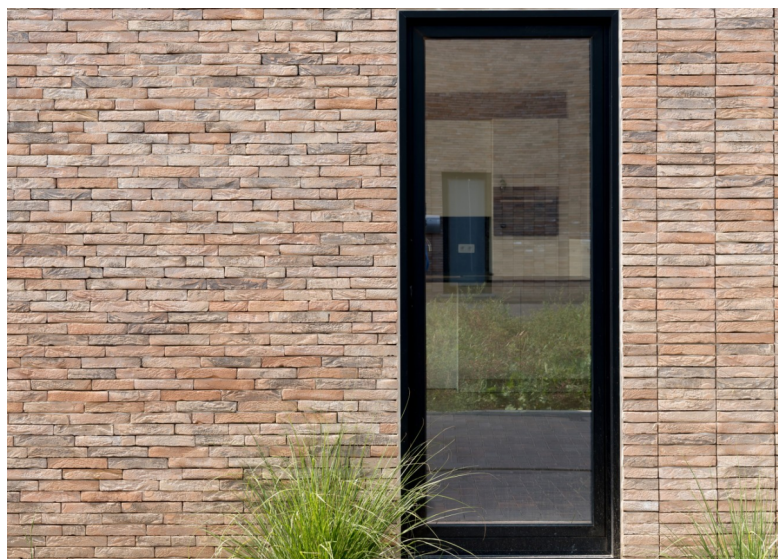
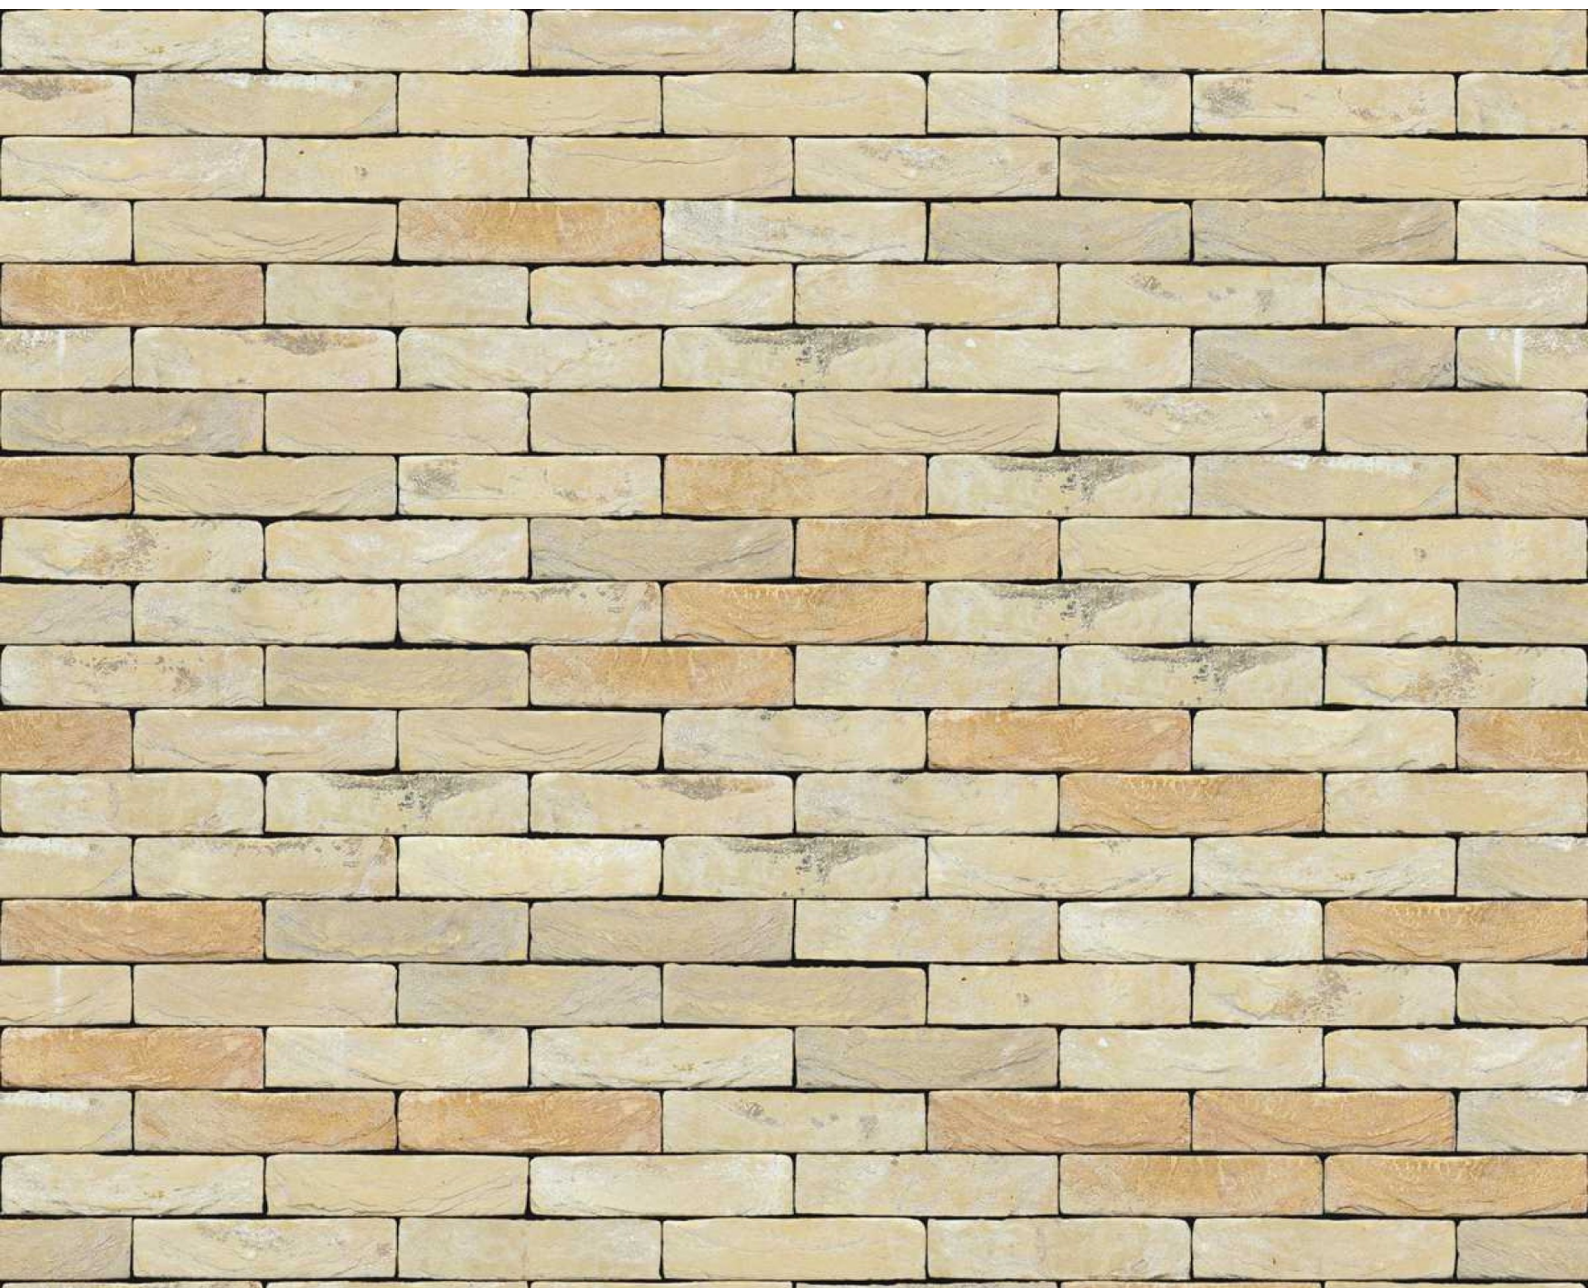
The (non-perforated) facing brick is sanded on five sides. The surface may be given a frog (a slanted oblong groove) on its bed. The structure looks rugged with fine and irregular grooves in the sandy surface. The firing process takes place in a gas-heated tunnel kiln.

The brick has a yellow base. The various types of sand are responsible for colours, ranging from yellow to soft pink with beige, grey and orange shadings. The colours shown are a near reflection of reality.
