This hand-moulded facing brick is made from loess, which is extracted among others from the Kesselt plateau in the Maas valley (Belgium) and then enhanced with raw materials from the Volcanic Eifel.

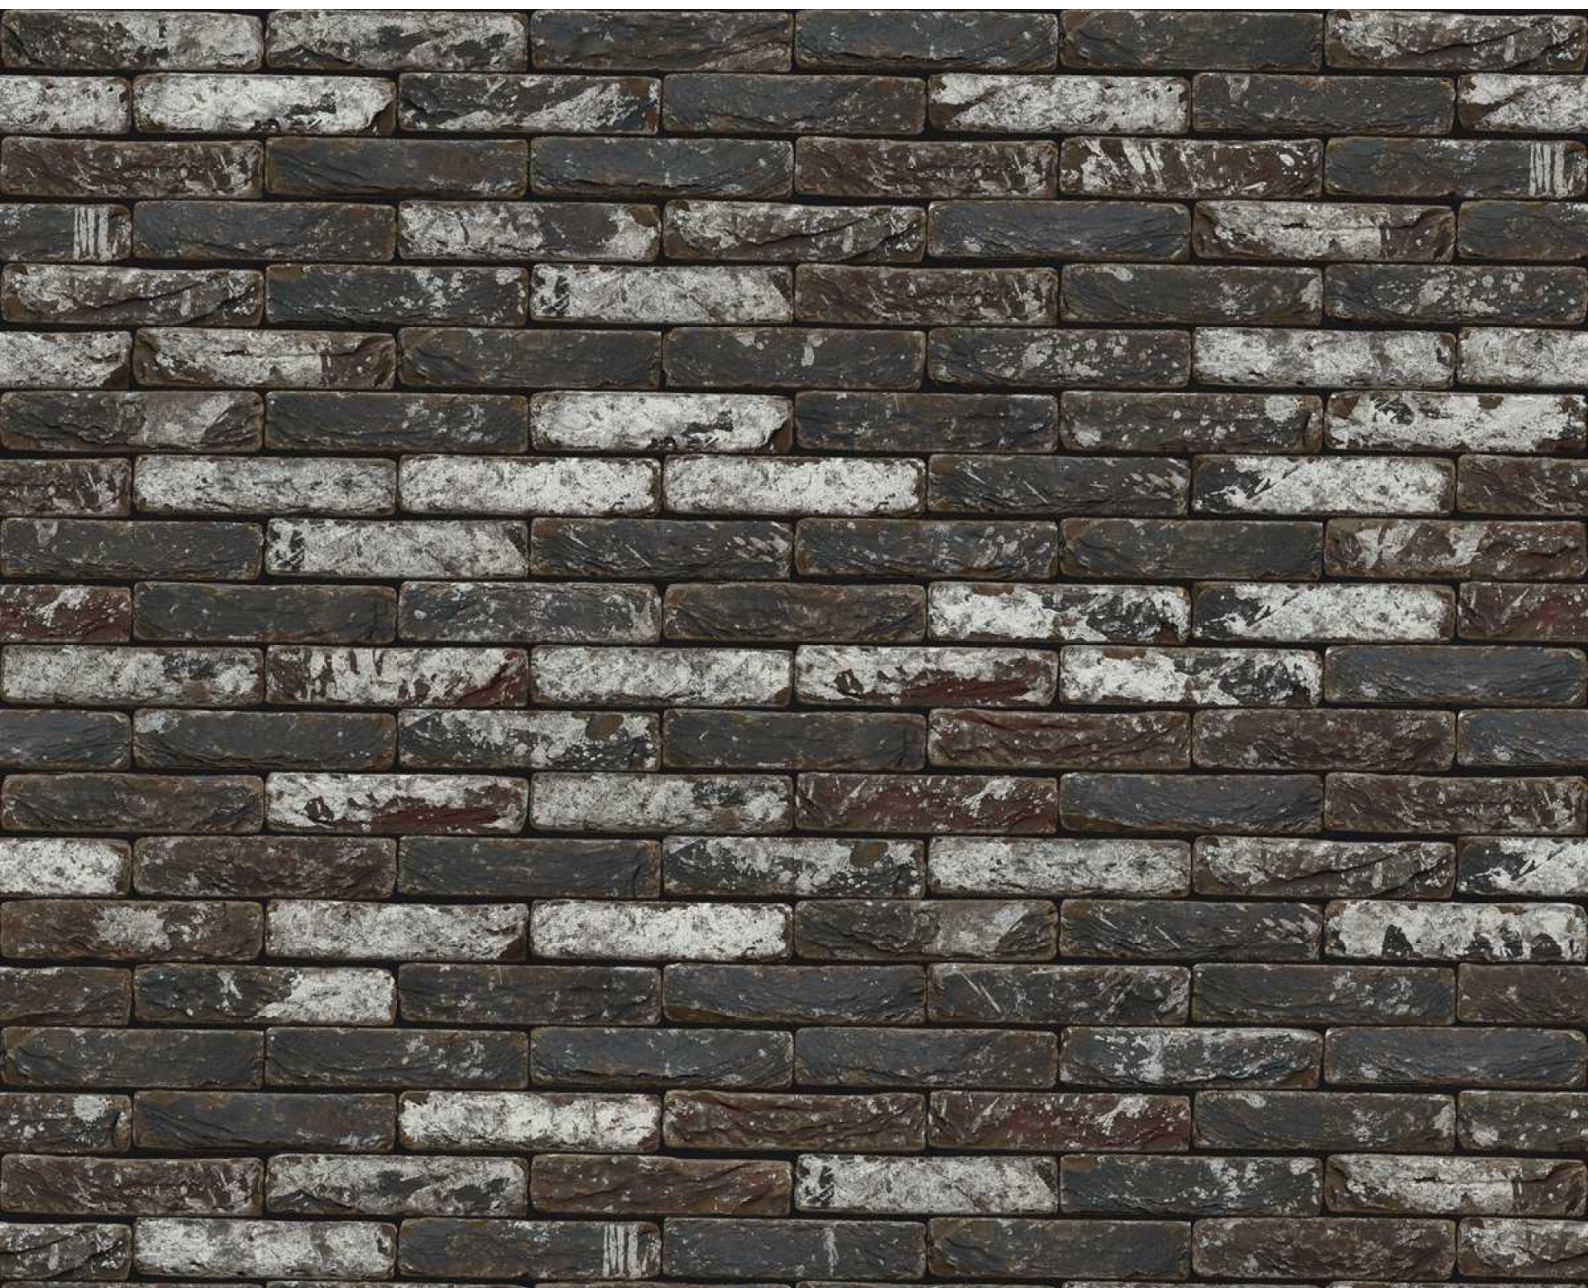
The (non-perforated) facing brick is sanded on five sides. The surface may be given a frog (a slanted oblong groove) on its bed. The firing process takes place in a gas-heated tunnel kiln. The bricks have a rough structure, irregular shape, and a strong resemblance to recovered bricks. The brick's retro appearance is achieved by using a tumbling process.

The colour varies from mainly anthracite to coal black, with blue and brown nuances and white deposits visible. The ageing process also influences the colour shades. The colours shown are a near reflection of reality.
