This hand-moulded facing brick is made from loess, which is extracted among others from the Kesselt plateau in the Maas valley (Belgium) and then enhanced with raw materials from the Volcanic Eifel.

#### ASPECT AND STRUCTURE

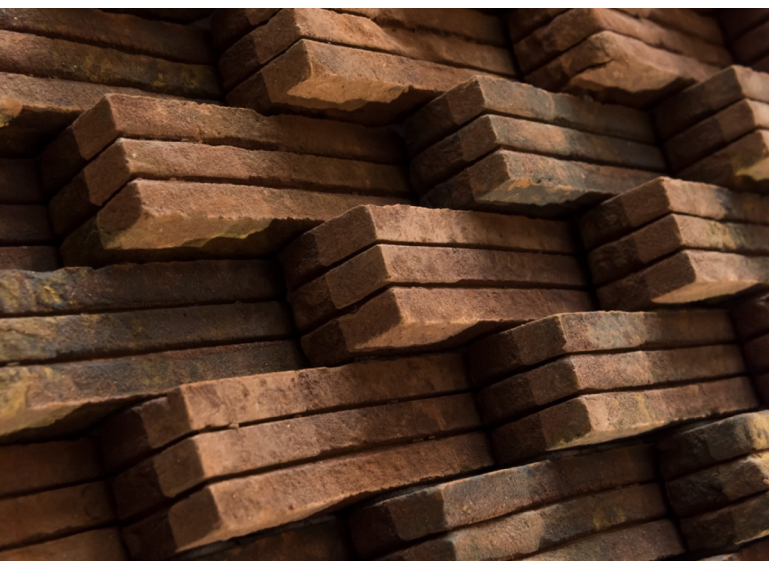
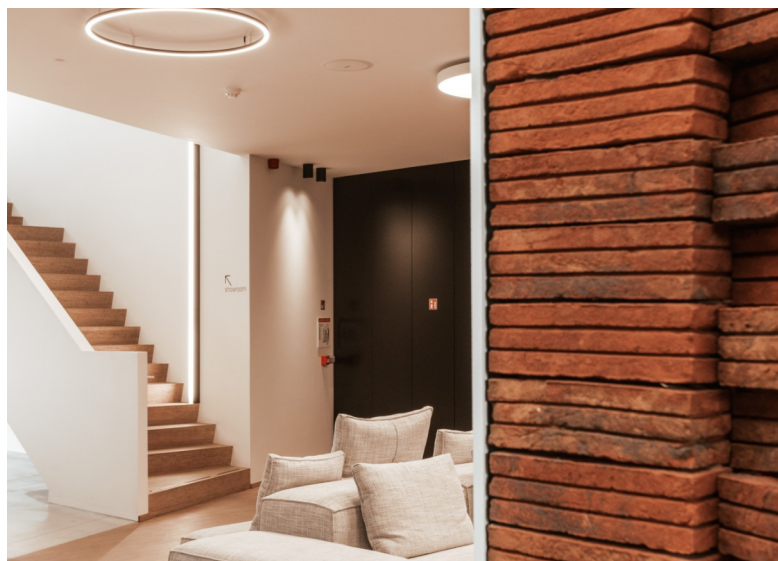
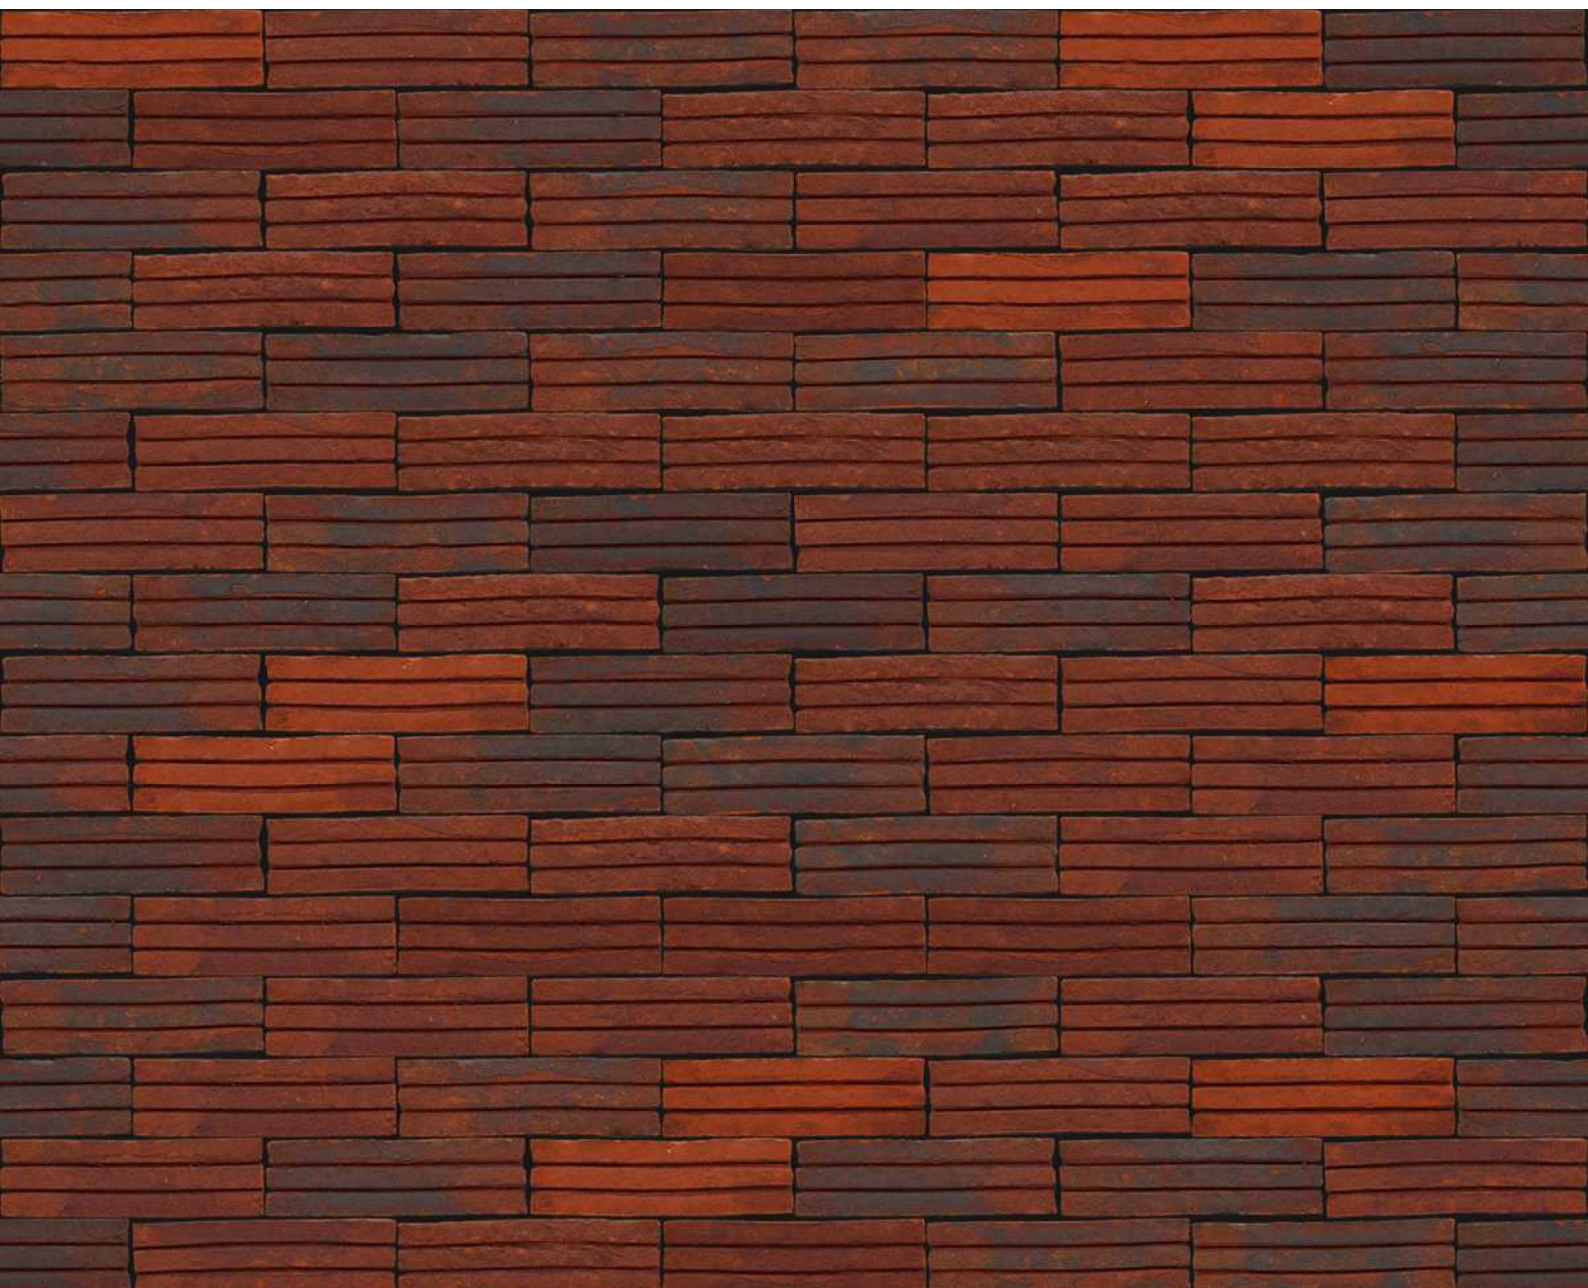
The (non-perforated) facing brick is sanded on five sides. The structure looks rugged with fine and irregular grooves in the sandy surface. The firing process takes place in a gas-heated tunnel kiln. DUBIO exists in 2 variants: DUBIO 1 = DUBIO with 1 shadow joint on the stretcher face (asymmetrical shadow joint) and DUBIO 2 = DUBIO with 2 shadow joints on the stretcher face (double symmetric shadow joint). The line pattern continues on at least one header face of the brick. The thickness of the shadow joint is  $\pm 4$  mm.

The brick has a red base, with hues that vary from orange red to burgundy with blue, yellow-green and dark-purple shades. The colours shown are a near reflection of reality.
