This hand-moulded facing brick is made from loess, which is extracted among others from the Kesselt plateau in the Maas valley (Belgium) and then enhanced with raw materials from the Volcanic Eifel.

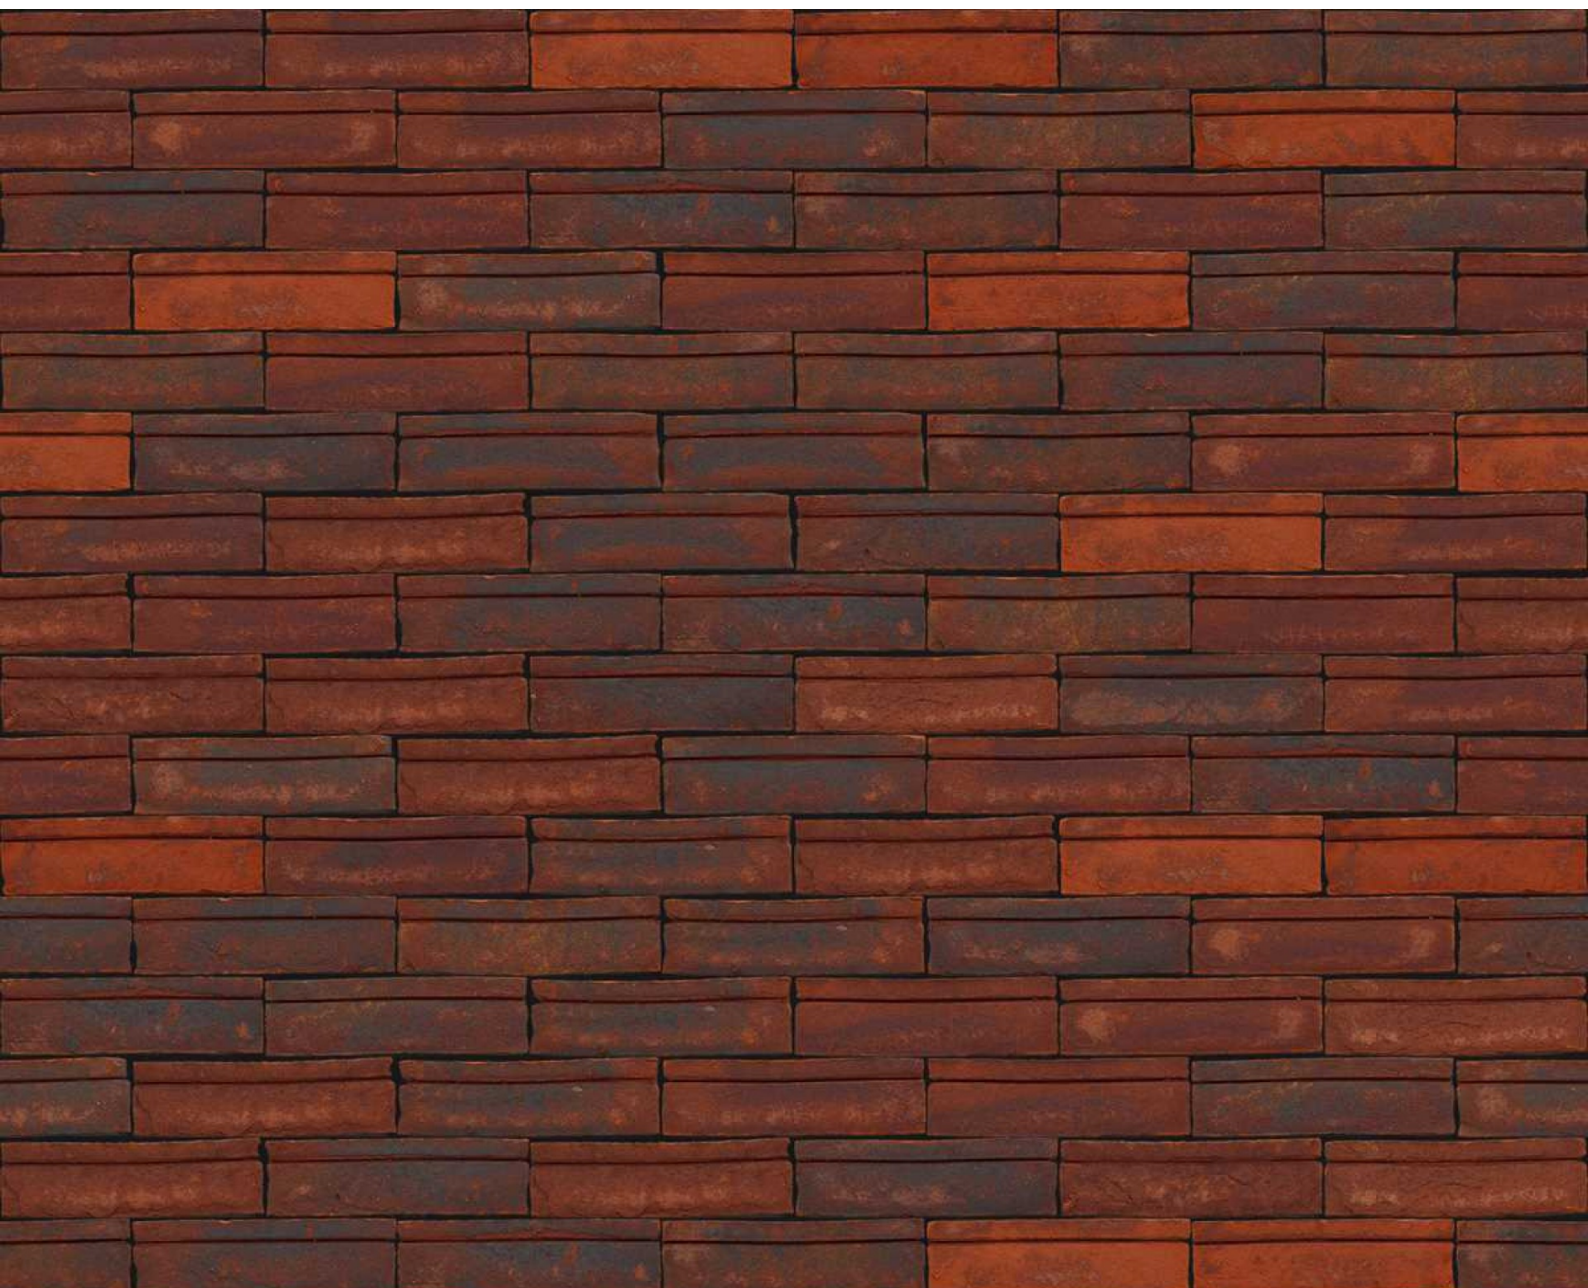
The (non-perforated) facing brick is sanded on five sides. The structure looks rugged with fine and irregular grooves in the sandy surface. The firing process takes place in a gas-heated tunnel kiln. DUBIO exists in 2 variants: DUBIO 1 = DUBIO with 1 shadow joint on the stretcher face (asymmetrical shadow joint) and DUBIO 2 = DUBIO with 2 shadow joints on the stretcher face (double symmetric shadow joint). The line pattern continues on at least one header face of the brick. The thickness of the shadow joint is  $\pm 4$  mm.

The brick has a red base, with hues that vary from orange red to burgundy with blue, yellow-green and dark-purple shades. The colours shown are a near reflection of reality.
