This hand-moulded facing brick is made from loess, which is extracted among others from the Kesselt plateau in the Maas valley (Belgium) and then enhanced with raw materials from the Volcanic Eifel.

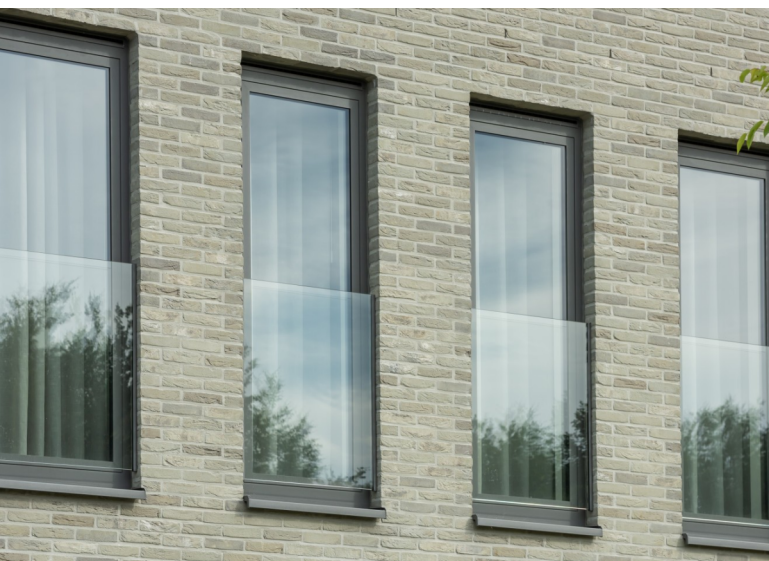
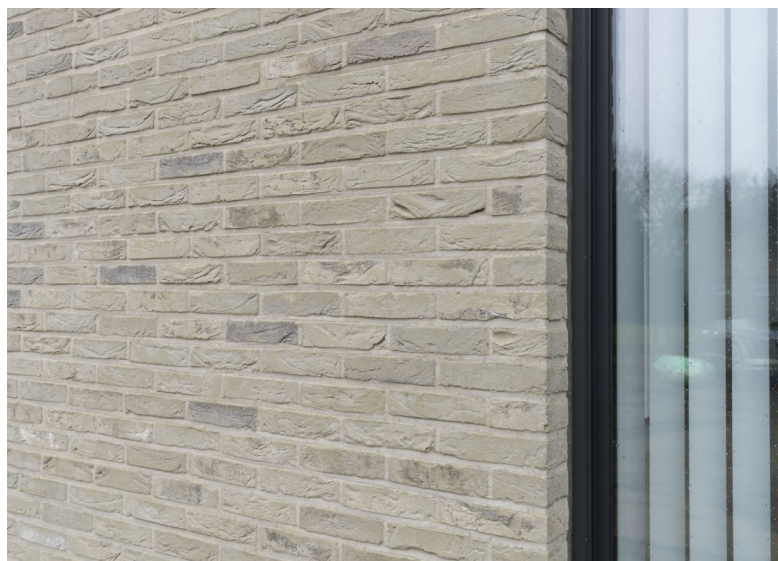
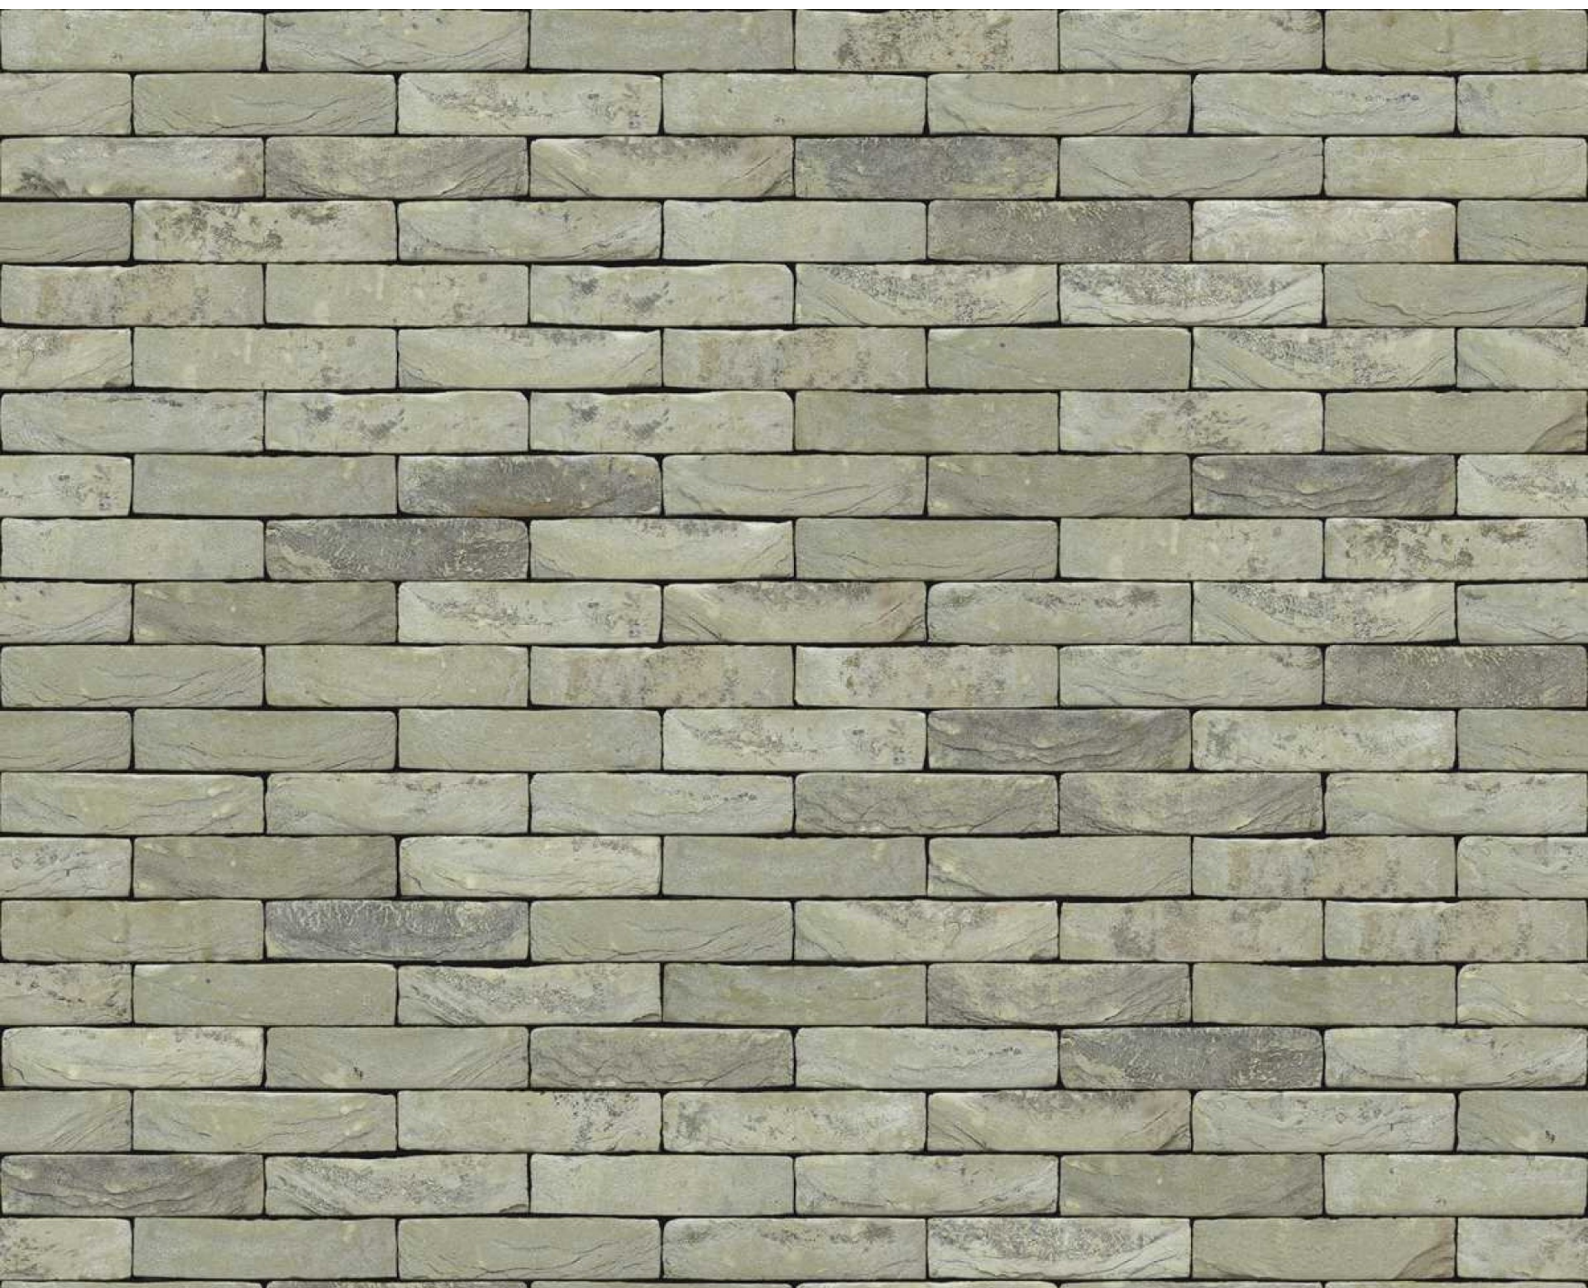
The (non-perforated) facing brick is sanded on five sides. The surface may be given a frog (a slanted oblong groove) on its bed. The structure looks rugged with fine and irregular grooves in the sandy surface. The firing process takes place in a gas-heated tunnel kiln.

The brick has a green-grey base. The colour is obtained by a second firing of the bricks in a low oxygen environment. This process is responsible for colours that range from light grey to dark gray with green-grey shadings. The colours shown are a near reflection of reality.
