This hand-moulded facing brick is made from loess, which is extracted among others from the Kesselt plateau in the Maas valley (Belgium) and then enhanced with raw materials from the Volcanic Eifel.

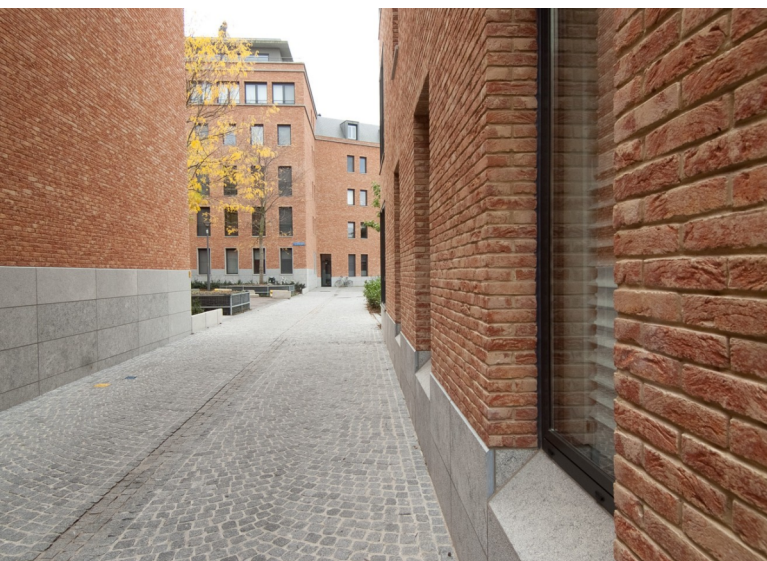
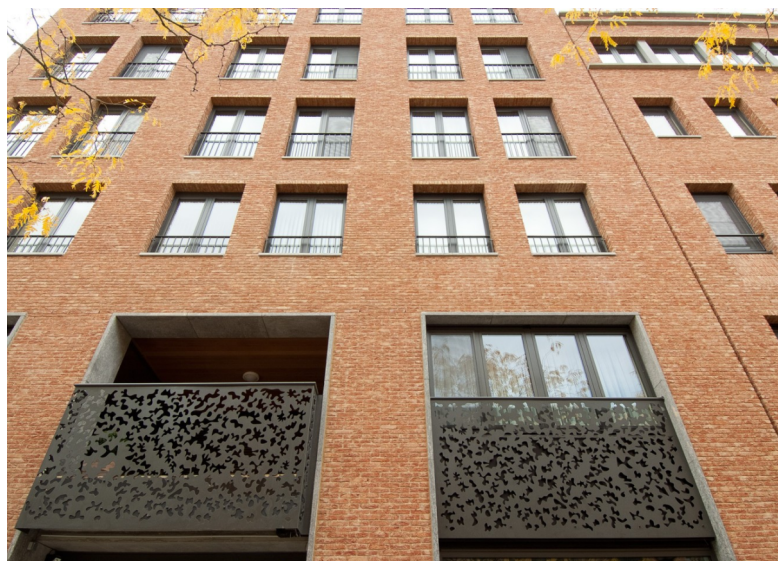
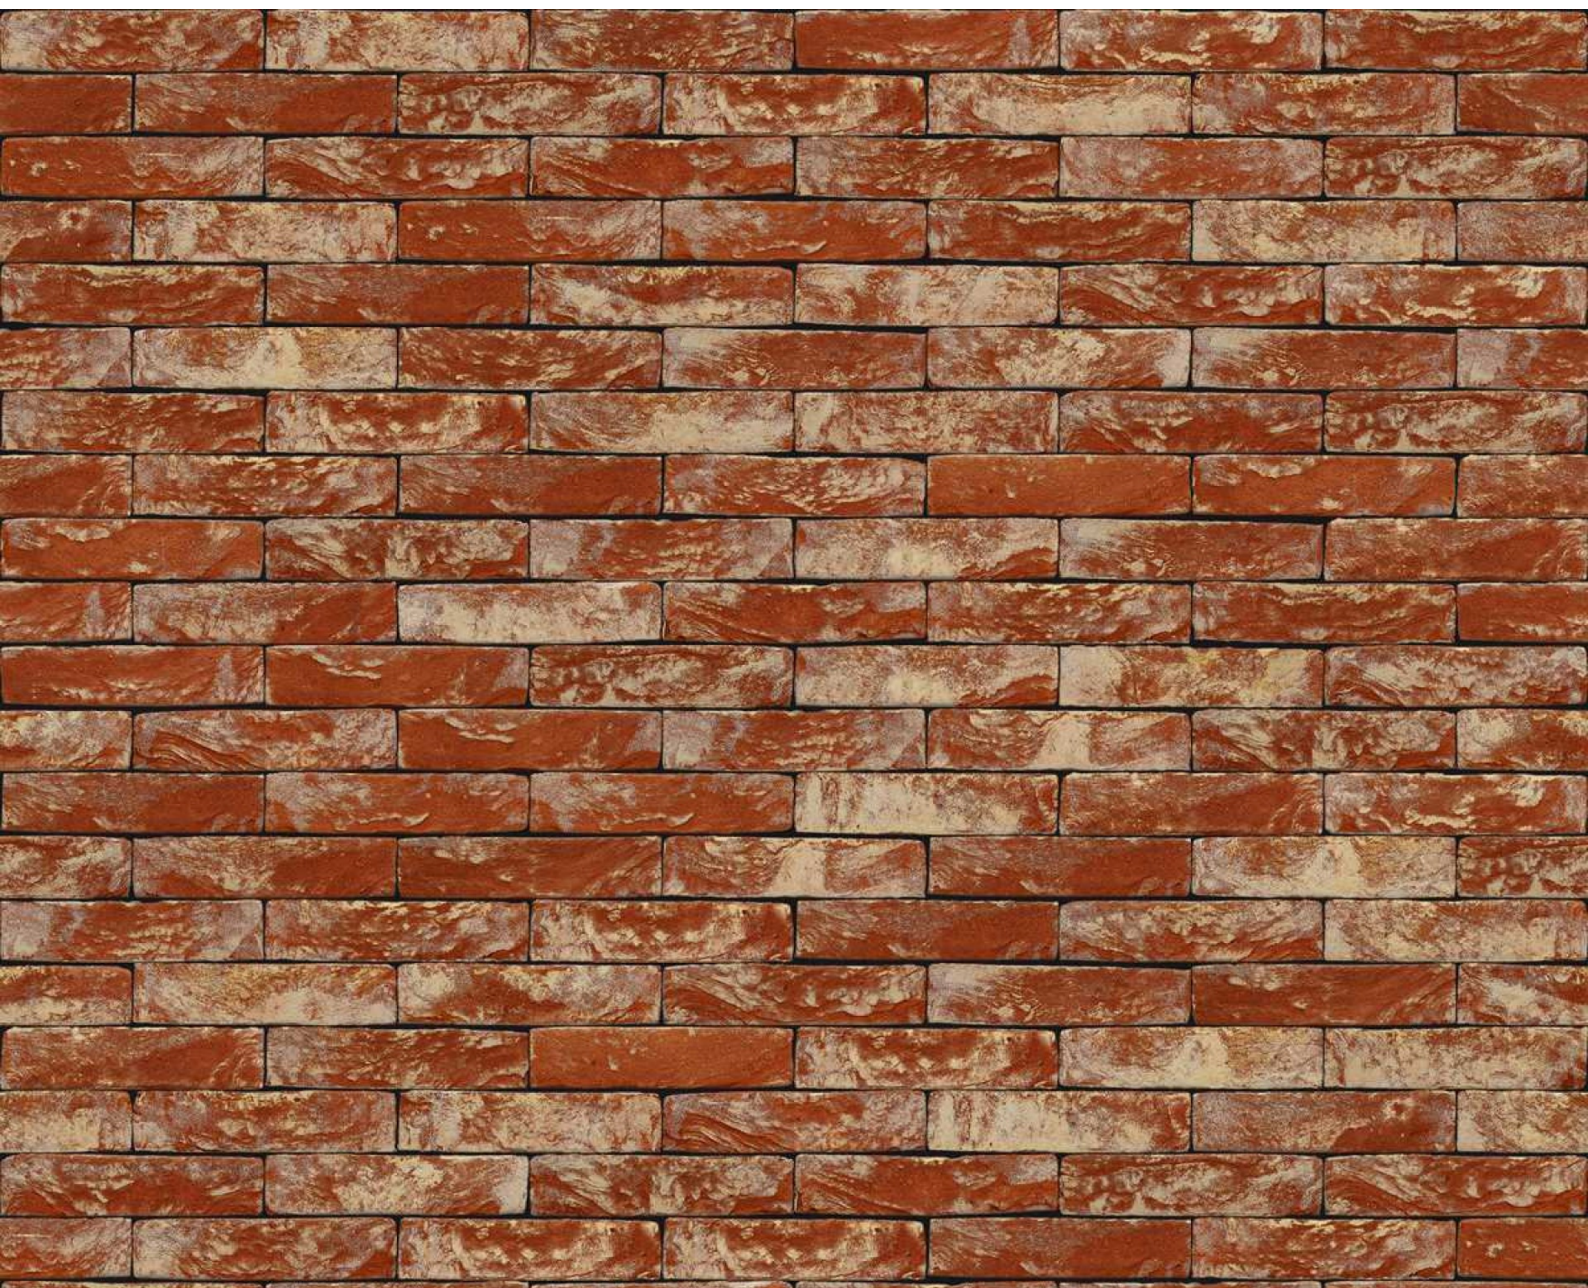
The (non-perforated) facing brick is sanded on five sides. The surface may be given a frog (a slanted oblong groove) on its bed. The structure looks rugged with fine and irregular grooves in the sandy surface. The firing process takes place in a gas-heated tunnel kiln.

The brick has a yellowish base, and the colour variations show hues ranging from orange red to wine red alternated with yellow shadings. The colours shown are a near reflection of reality.
